Field Modification Note

075063500

KALYPSO

2-M/E MAIN CONTROL PANEL (660-0005-00)

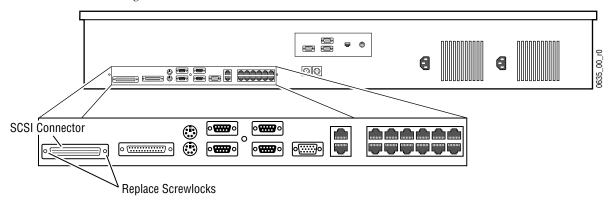
Figure 1. 2-M/E Control Panel SCSI Connector

This field modification corrects a problem with the SCSI cable connectors on the rear of the Kalypso 2-M/E and 4-M/E Main Control Panels. The screwlocks originally installed on the control panels' SCSI connectors are too long and may prevent SCSI cable connectors from securely mating with the corresponding panel connectors. This may in turn result in intermittent problems with the CD-ROM, Zip drive, or other devices in the SCSI chain. This field modification requires replacing the two screwlocks installed in the panel SCSI connector with the two new screwlocks provided. This will allow a secure cable connection and preclude any intermittent problems in the SCSI chain associated with an insecure cable connection at the panel.

- **3.** Remove the SCSI cable by loosening the jackscrews holding it in place.
- **4.** Examine the screwlocks installed in the connector to determine if they are flush with the end of the connector. If the screwlocks extend beyond the end of the connector, the new screwlocks provided with this kit should be installed.
- **5.** Remove the existing screwlocks with a nut driver and install the new ones provided.

- **6.** Make sure the new screwlocks are flush with the SCSI connector and reinstall the SCSI cable. Verify that the cable connection is secure.
- **7.** Turn power back on to the control panel.
