Title: Ocelot Communication Bus Terminator (ECO-CE00029)

Product: Ocelot Routing Switcher Systems.

Date: November 8, 2000

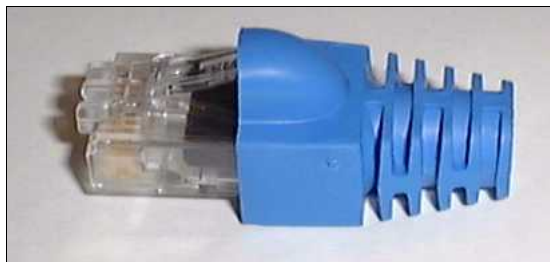
Under certain conditions, reflections on the Ocelot communication bus can cause control panel push button lamps to flicker.

Figure 1. Ocelot Communication Bus Terminator

A redesigned Ocelot Controller Assembly is used with Ocelot Communication Bus Terminators (PESA Part No. 81-9065-2189-0) to eliminate this problem.

6. **Bus Termination:** Each RCP bus shall be terminated as follows:
 - a. **Daisy-Chain:** An RCP bus terminator shall be installed in the unused RJ-45 connector on the last RCP in every daisy chain.

- b. **Main Frame:** An RCP bus terminator shall be installed in all unused RJ-45 connectors on the main frame.
