## Technical Bulletin

81-9059-0417-0 C

### Bobcat Software Upgrade v1.4 to v1.5 (ECO 3181, CE00126)

**Product:** Bobcat Routing Switcher

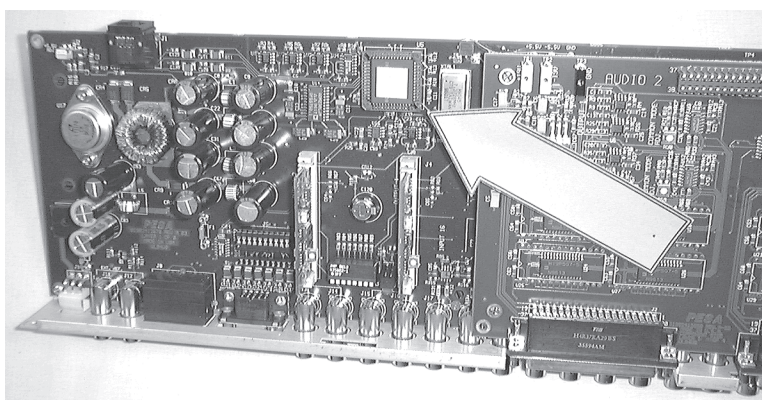
Figure 1. Orientation View

**Issue:** U5, a single chip microcontroller on the Bobcat motherboard, requires replacement to upgrade the software from v1.4 to v1.5.

1. If your Bobcat has push buttons on the front panel, remove the four screws (two on the top plate and two on the bottom plate) that secure the front panel to the chassis. If your Bobcat does not have push buttons on the front panel, skip to Step 3.
2. Disconnect the cable from the RJ-45 connector on the front panel and carefully lay the front panel aside.
3. Remove the two screws on the back which secure the motherboard to the chassis and remove the motherboard.
4. Locate U5 on the motherboard as shown by the arrow in Figure 1.
