SSA424 Engineering Advisory

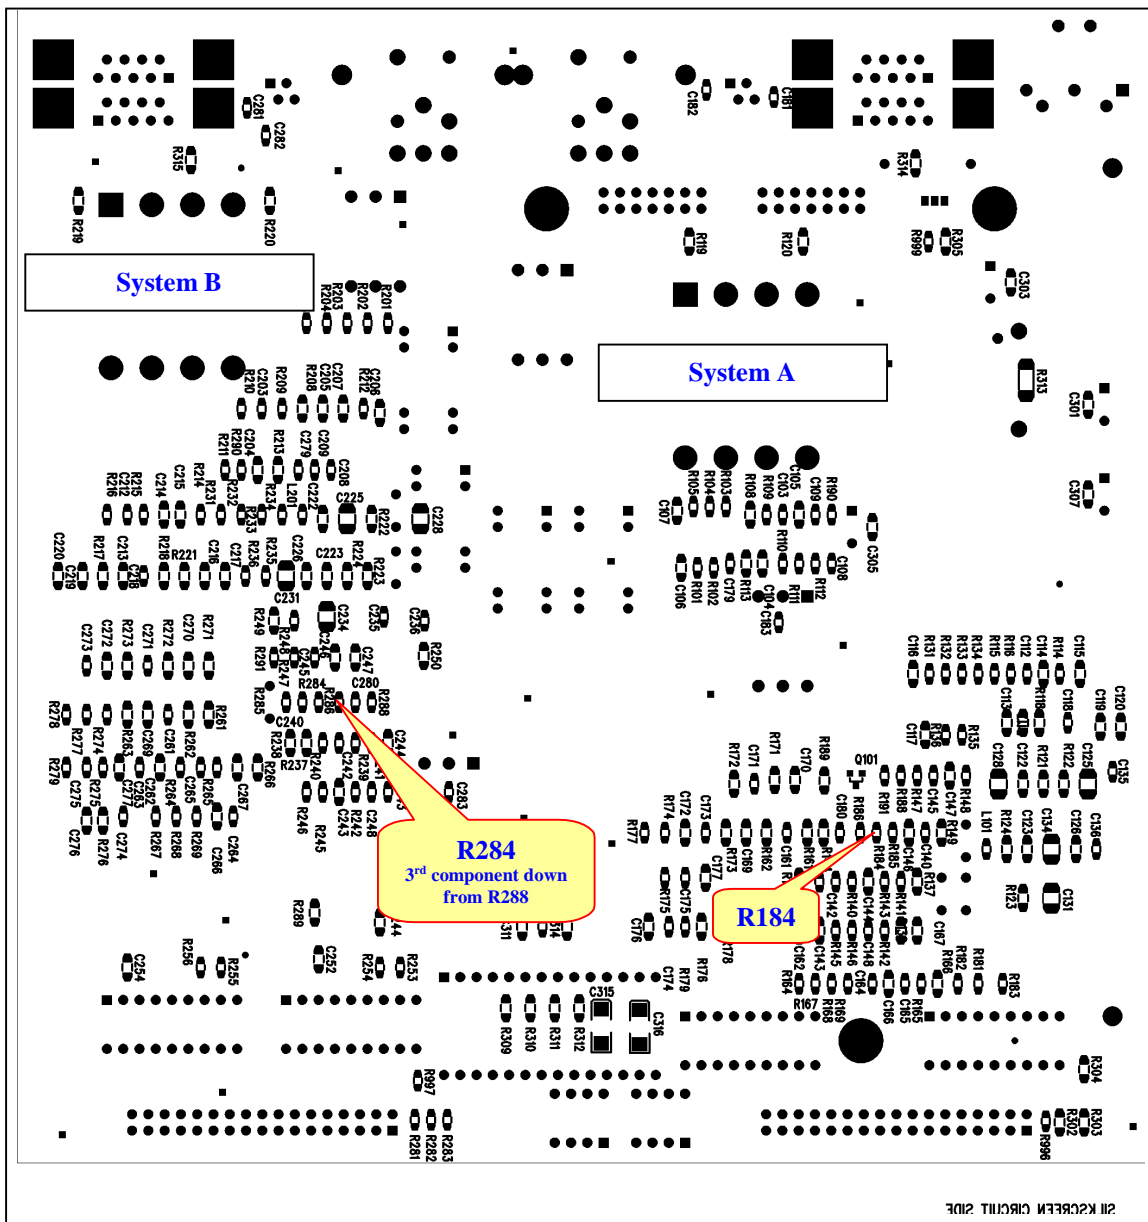
There has been incorrect resistor value installed in some SSA424's which affects the "full duplex sense" circuit causing it not to automatically go into the full duplex mode. R184 and R284 were installed at the factory as 100k ohm instead of 1k.

The problem is the unit will not go into full duplex in a timely manner and the unit doesn't work according to the manual. Normally when only dip switch #1 is on, three seconds after someone starts speaking on the four wire, the unit will move into full duplex. If the conversation on the four wire stops for over 30 seconds, the unit will probably stay in full duplex but is allowed to drop into half duplex. This may happen if the SSA feels it needs to readjust itself due to any changes in the system's line characteristic. When after three seconds of conversation on the 4 wire starts up again, the unit will transition once again into full duplex mode.

The "easy" work around is to turn **ON** both dip switches **1** and **4** which locks the SSA into full duplex. There are two known problems with this temporary solution. One is that the circuit may give a short "tweet" when some TW devices are added or subtracted from the intercom line. Second is the SSA is no longer a truly automatic interface.
