**Field Replacement of new MADI Back Card and mating with existing MADI Front Card**

# **RTS™** TECHNICAL BULLETIN

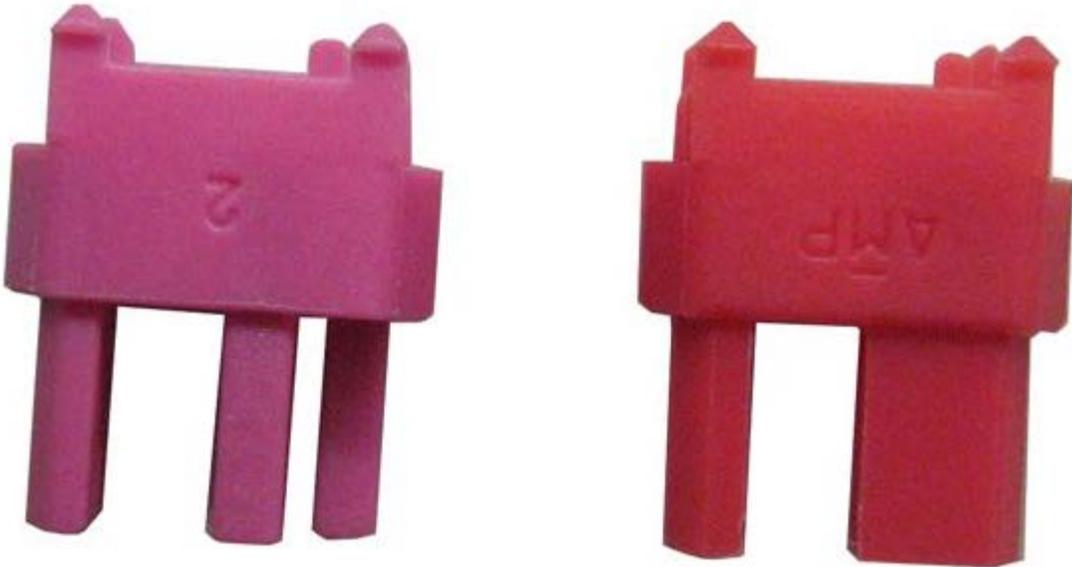
The left key is the new Heather Violet key. The right key is the old Strawberry Red key.

The new MADi Back Card arrives with a new connector key already installed. The new connector key is a different color. The new color is **violet**. The color of the old key is red.

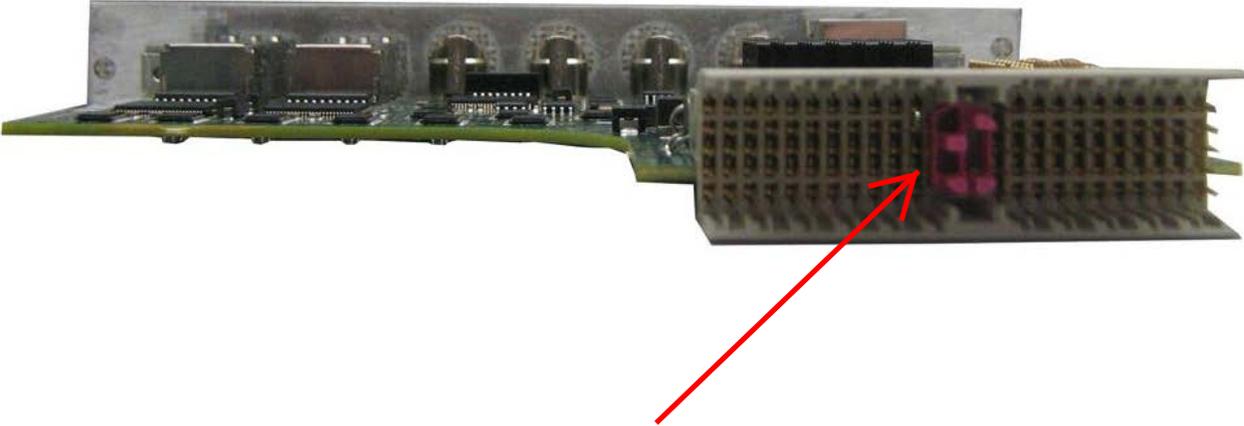
Shown below is a MADi Back Card with the new connector key.

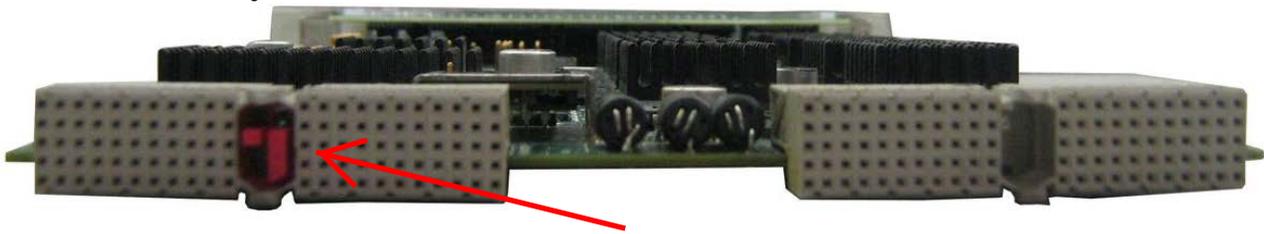
The old connector key is shown installed in the MADI Front Card.

2. Remove MADI Front Card from the frame.
