# Broadcast Products

## Technical Bulletin 20-2009-128

SUBJECT: PEDESTAL LEVEL OF TEST SIGNAL UNDULATES  
ON RIGHT AND LEFT SIDES

MODEL: *HDC1000//ULW*  
*HDC1000/LB*  
*HDC1000/LW*  
*HDC1000/LW*  
*HDC1400//UL*  
*HDC1400/L*  
*HDC1450//UF*  
*HDC1450/K*  
*HDC1500//UL*  
*HDC1500/L*  
*HDC1500/L*  
*HDC1550//UF*  
*HDC1550/K*  
*HDC1580/L*  
*HDC1580/T*

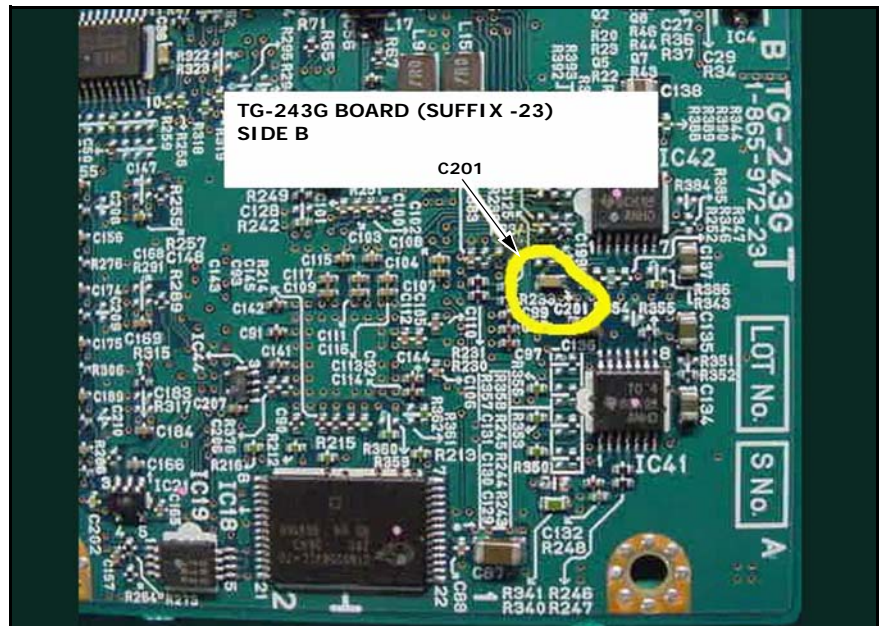
The pedestal level of the analog test signal (TestSaw/3-step) waveform may undulate on the right and left sides. This symptom occurs when a TG-234G board with suffix -23 is used in the CCD block.

1. Remove the TG-243 board as described in the service manual, volume 1, section 2-2, "Replacement of CCD Unit Boards."
2. Replace C201 with a new 4.7  $\mu$ F capacitor. (See Figure 1.)
3. Reinstall the TG-243 board and CCD unit.
