Broadcast Products Technical Bulletin 20-2007-195

SUBJECT: CAMERA DOES NOT SWITCH FROM STANDBY
TO MAIN AT POWER-ON

MODEL: **HDC1000/LB**
HDC1000/LW
HDC1000/LW
HDC1000/LW1
HDC1000/LW2
HDC1500//UL
HDC1500/L
HDC1500/L
HDC1500/L1
HDC1500/L2
HDC1580/L
HDC1580/L1

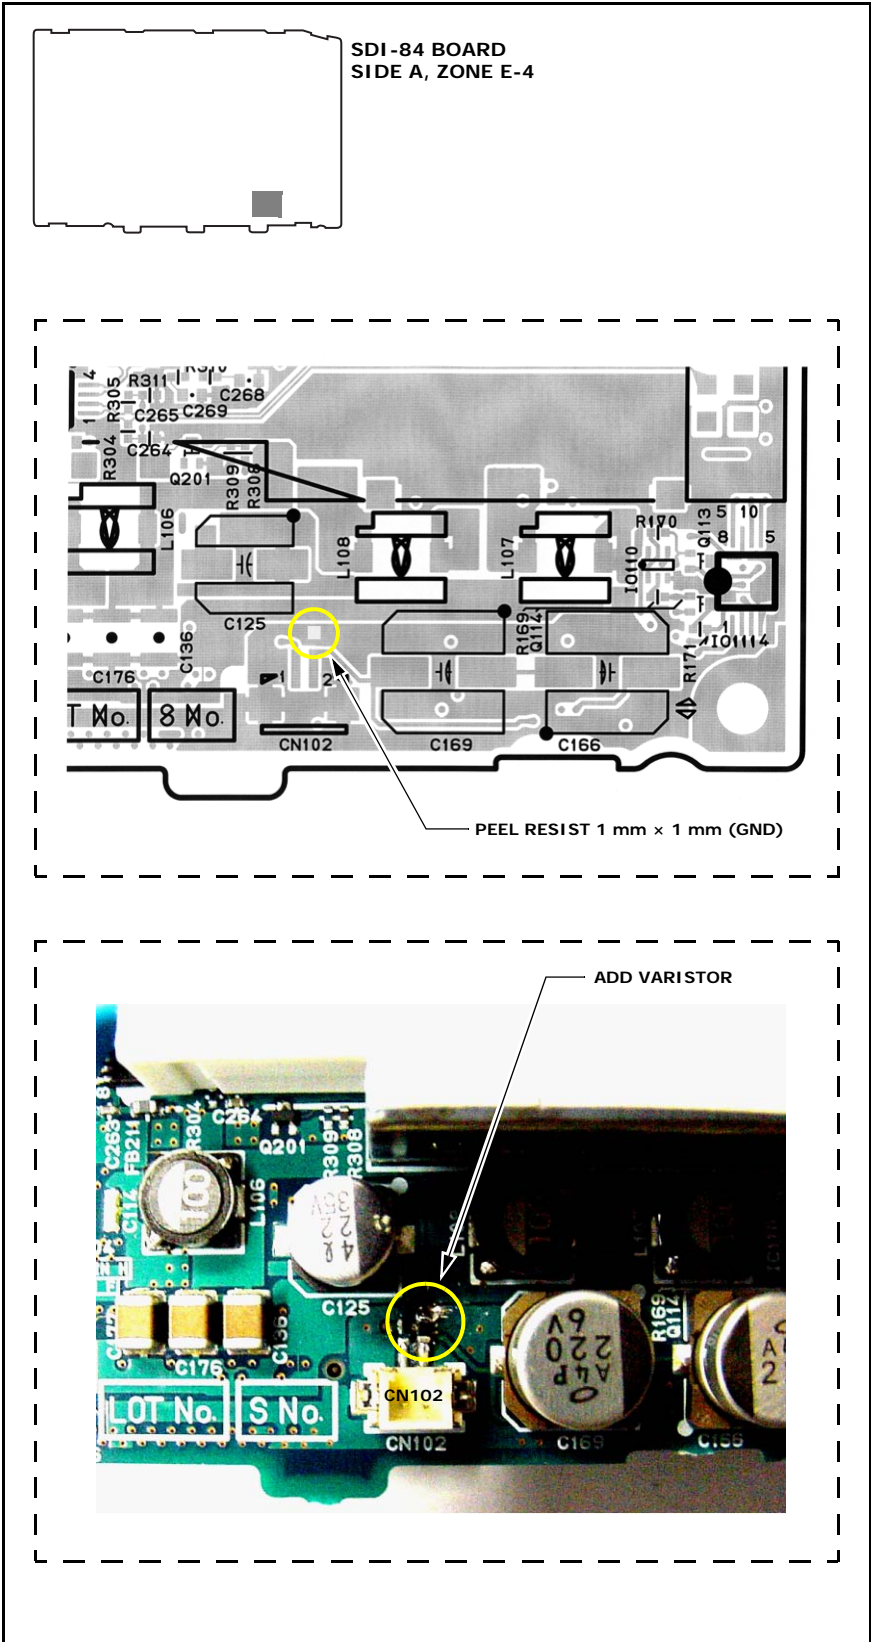
Figure 1

On rare occasions, the camera may not switch from Standby to Main when CAM POWER is turned ON. This symptom may occur if external noise (such as a surge) interferes with the transmission cable between the camera and CCU, resulting in damage to IC110 and IC113 on the SDI-84 board.

1. Remove D111 (side B, zone F-4).
2. Use a utility knife to peel resist near CN102 pin 2 (side A, zone E-4) the size of 1 mm × 1 mm to create a GND area. (See Figure 1.)
3. Solder a varistor between CN102 pin 2 and GND. (See Figure 1.)
