## Broadcast Products Technical Bulletin 20-2008-010

SUBJECT: B-Y CHANNEL LEVEL FLUCTUATION OF MAIN  
LINE CCU OUTPUT

MODEL: **HDC1550//UF**  
**HDC1550/F**  
**HDC1550/K**  
**HDC1550/K1**  
**HDC1550/K2**

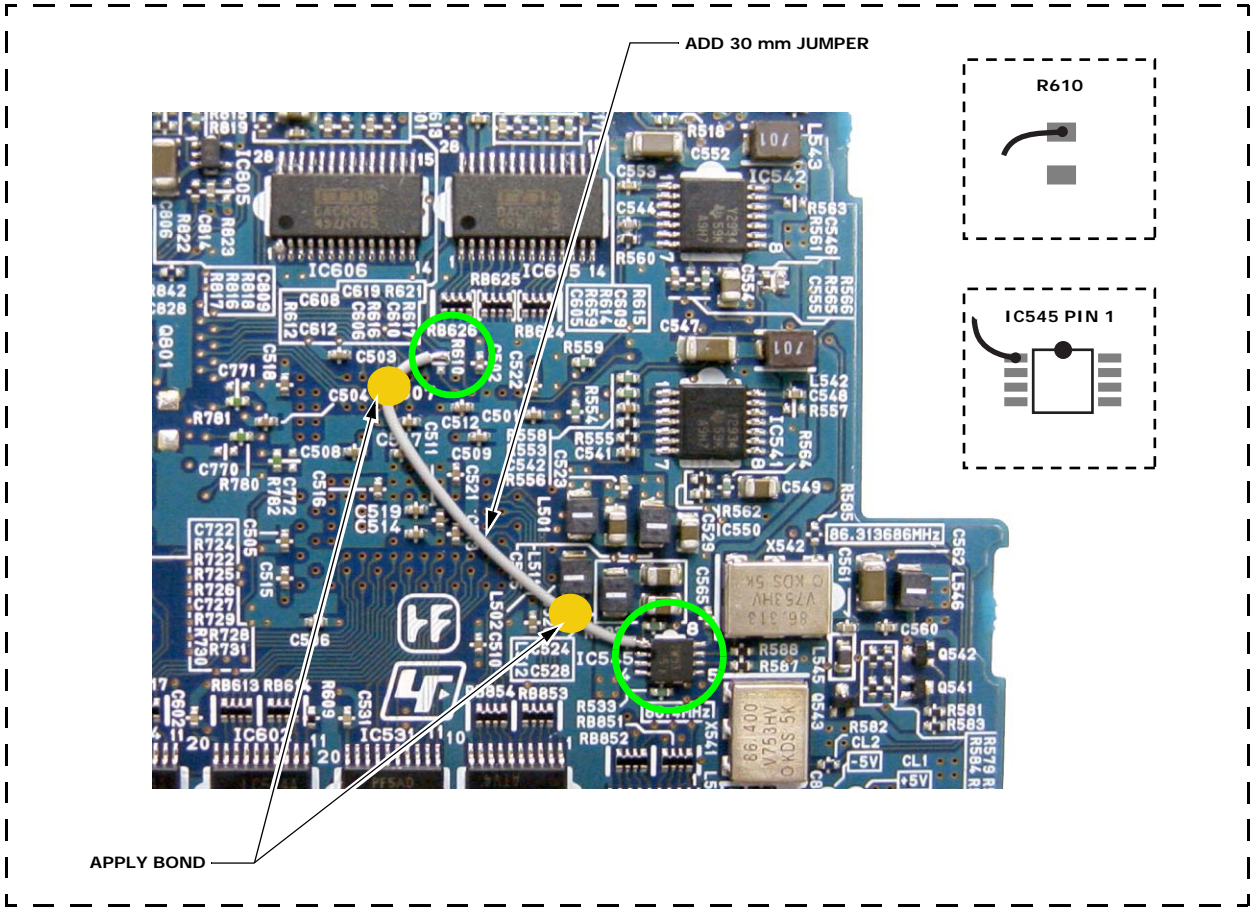
Figure 1

Irregular level fluctuation may be detected in the B-Y channel on the main line of the CCU output signal.

The fluctuation is so slight that it cannot be detected on the B-Y channel video monitor, but can be detected on the waveform monitor and is a maximum of approximately 5 mV.

#### TR-136/P Board (Side B, Zone A-2)

1. Remove R610.
2. Solder a jumper between R610 (upper pad) and IC545 pin 1.
3. Affix the jumper to the board with bond.
