Broadcast Products Technical Bulletin 20-2010-026

SUBJECT: HORIZONTAL BAR NOISE WITH 25PsF/29.97PsF

MODEL: *HDC1500//UL*
HDC1500/L
 HDC1500/L
 HDC1500/L1
 HDC1500/L2
HDC1500/T
 HDC1500/T2
HDC1550//UF
HDC1550//UF1
HDC1550/F
 HDC1550/K
 HDC1550/K1
 HDC1550/K2

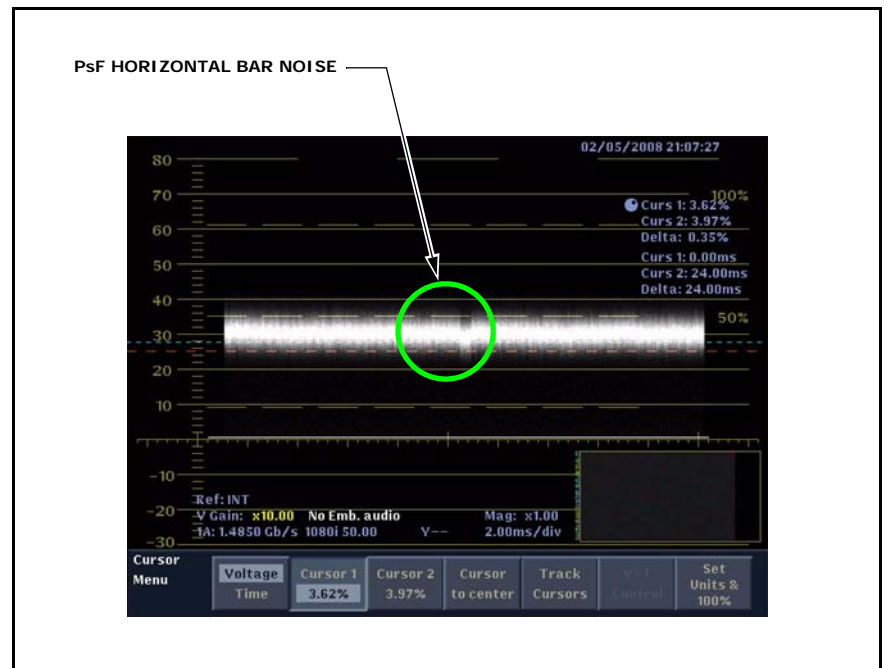
Figure 1

Faint horizontal bar noise may appear on the screen while running in 1080/25PsF, 1080/29.97PsF modes. (See Figure 1.)

NOTE: The amount of noise differs among individual cameras.

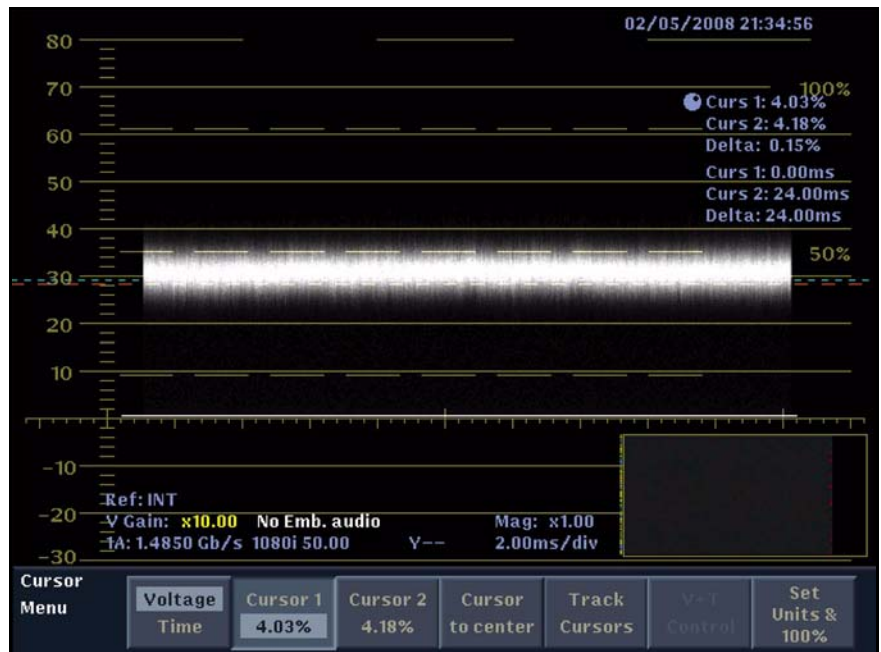
Figure 3

- Video output is normal in 1080/25PsF, 1080/29.97 PsF modes.
- Horizontal bar noise is improved. (See Figure 3.)
