## D/A Converter 1.949.688.00

## Vista Service News July 2005

## Vista Service News November 2005

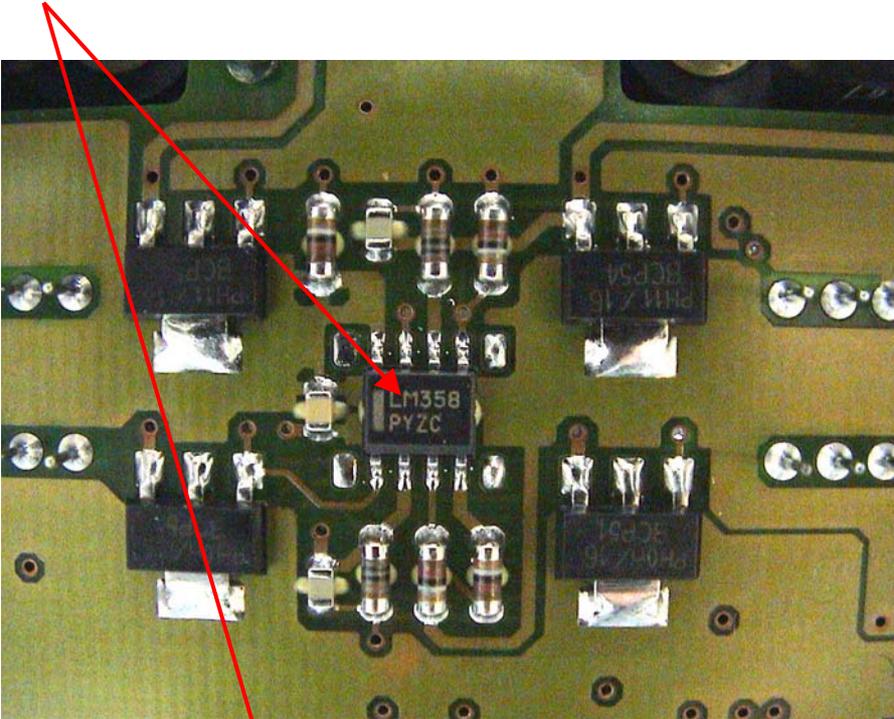
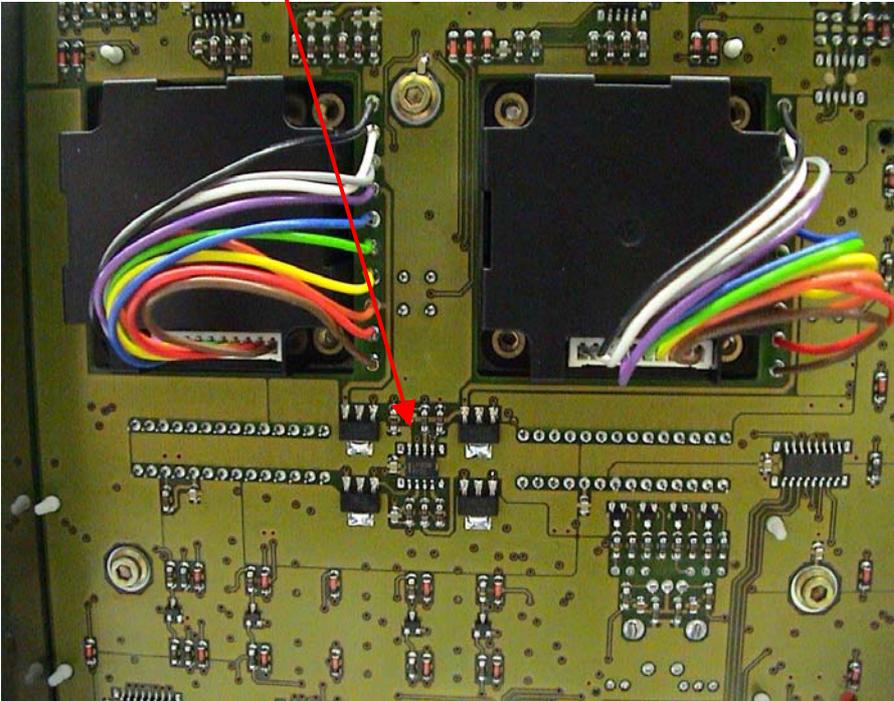
**Vista 7 Center Frontboard (Bottom) 1.949.125.00**

Modification 16.7.2002 (to Index "A")

IC 16 : TL062 replaced with LM 358 D.

(plus 2 x 100nF between AGND and Chassis)

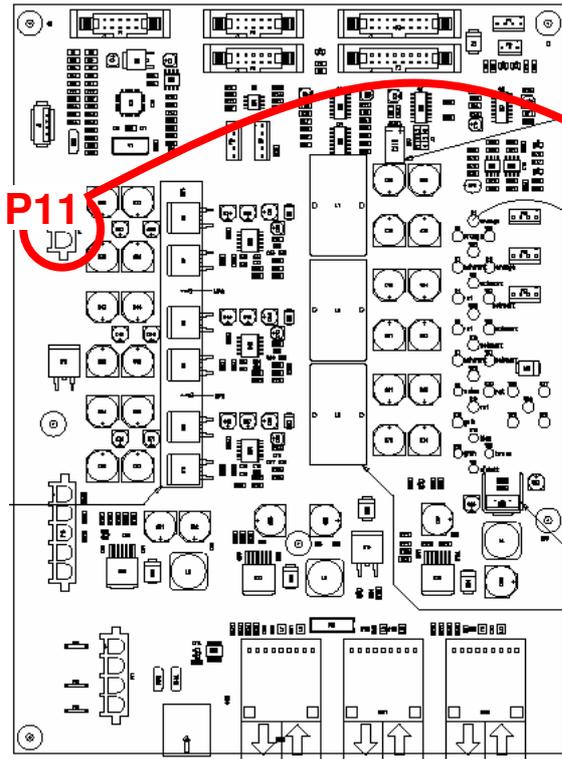
1.949.152.00 Distribution Board Redundant

The redundant PC of the Vista 8 is currently supplied from a single supply. In case of a defect supply of the redundant PC, not only the redundant system would fail, but also the main PC because signals are switched on the redundant distribution board.

The following connection with the main distribution board (1.949.150.81) provides a redundant 24V supply for the 1.949.152.00 board as well for the whole redundant PC.

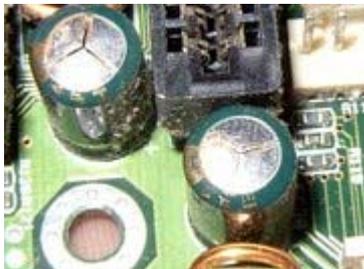
We did recently identify 3 boards in Vista systems (shipped at different dates) which showed the symptom with domed capacitor tops (see picture at left). As a result of the dramatically reduced value of these capacitors (part of the on-board DC-DC converter) the PC did not start anymore.

The boards could be repaired by replacing the defect capacitors.

- a visual inspection of the motherboard should be done whenever there is a boot or freeze problem of the Vista PC system, a check is also recommended as a preventive step of regular maintenance.  
If there are any capacitors with bulged or domed tops (see examples above or on web links) or if there are any leaking capacitors, Studer can either provide suitable replacement capacitors (see following instruction), or can arrange a replacement of the board.

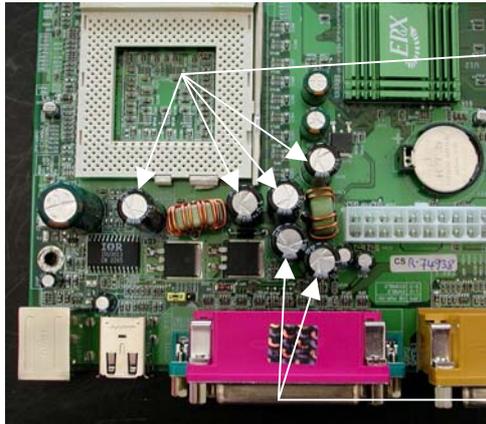
Replacement of the critical capacitors on Vista Motherboard (EPoX EP-3PTA, Studer Part No 89.20.1122)

2200 uF  
6.3V / 105 °C

1500 uF  
6.3V / 105 °C

Replacement of the capacitors should be left to qualified personnel with the proper tools. A 6-layer board can be damaged when not carefully removing and inserting components !

The indicated capacitors (1500 and 2200 uF) should be replaced with high quality components with the same specifications. The Studer replacement kit includes 6 capacitors of 2200 uF for replacement of the original 1500 and 2200 uF ones.

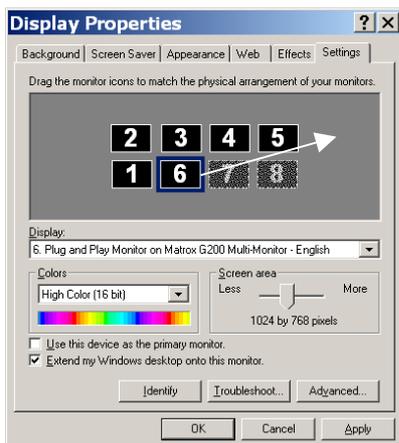
The configuration at right would not be correct, monitor 6 needs to be placed at the right of monitor 5.

After a restart, verify the correct arrangement of the newly detected card. Right-Click the desktop, choose "properties" and "settings" and arrange the fader bay monitors in a row, and the control bay monitor at the bottom left position.

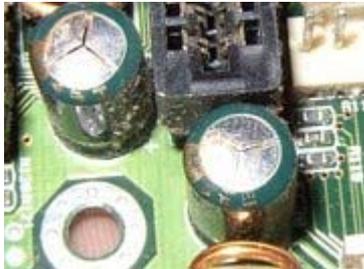
We did identify some boards in Vista systems (shipped at different dates) which showed the symptom with domed capacitor tops (see picture at left). As a result of the dramatically reduced value of these capacitors (part of the on-board DC-DC converter) the PC did not start anymore.

The boards could be repaired by replacing the defect capacitors.

- a visual inspection of the motherboard should be done whenever there is a boot or freeze problem of the Vista PC system, a check is also recommended as a preventive step of regular maintenance. If there are any capacitors with bulged or domed tops (see examples above or on web links) or if there are any leaking capacitors, Studer can either provide suitable replacement capacitors (see following instruction), or can arrange a replacement of the board.

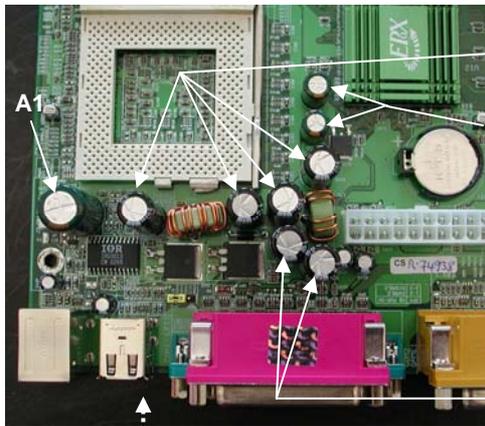
### Replacement of the critical capacitors on Vista Motherboard (EPoX EP-3PTA, Studer Part No 89.20.1122-E)

2200 uF  
6.3V / 105 °C

1000 uF  
6.3V / 105 °C  
(replace both with a single 2200 uF C)

1500 uF  
6.3V / 105 °C

Replacement of the capacitors should be left to qualified personnel with the proper tools. A 6-layer board can be damaged when not carefully removing and inserting components !

The indicated capacitors (1000, 1500 and 2200 uF) should be replaced with high quality components with the same specifications. The Studer replacement kit includes 7 capacitors of 2200 uF for replacement of the original 1000, 1500 and 2200 uF ones (7 x 10.597.680.05)

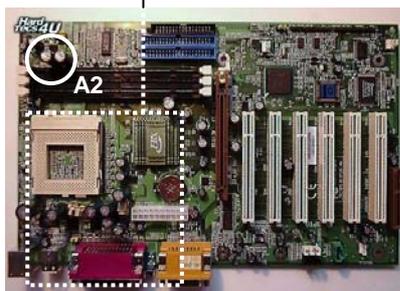
Further capacitors showed the effect in rare cases only, but will be generally replaced since autumn 2007 as well :

- 1 capacitor 3900 uF (see A1)  
-> with 10.597.680.06 (3300uF)
- 2 capacitors near RAM module (see A2)  
-> with 2 x 10.597.680.05 (2200 uF)
