## D21 Mic/Line In Card

**1.949.427.00/81**

The input of The Mic/Line In Card may be damaged when phantom power is switched on and the input signal is short circuited. This may e.g. happen when using patch bays with connectors causing a temporary short circuit during the plugging of the connector (was reported from bantam connectors).

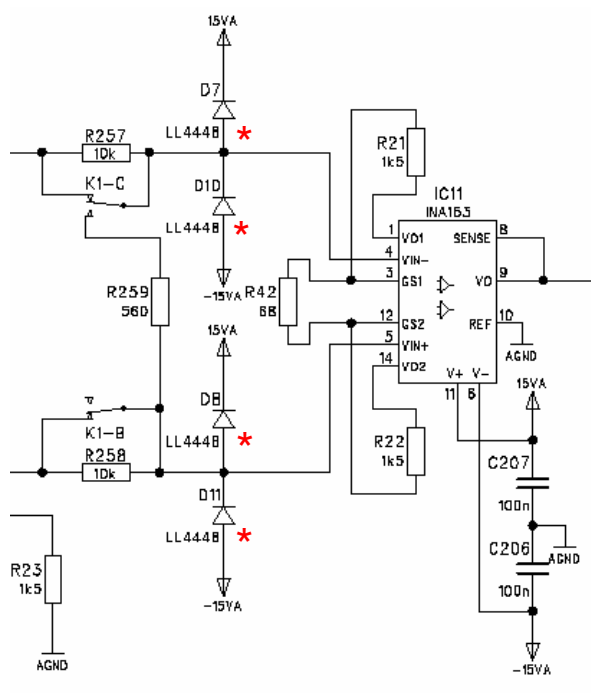
A first modification (Index 00 Rev "B" and Index 81) improved the problem, a later second modification (Index 00 Rev "C" and Index 81 Rev "A") fixes a resulting problem with clicks at a particular gain position.

In applications where the phantom conditions can't be avoided, the index 00 boards should be modified. Please contact the Studer Customer Support in such a case, for arranging a modification.

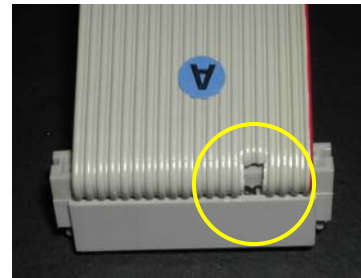
In a few Vista 8 systems, illegal characters or sequences were created when fast typing in names and numbers. The problem source is the keyboard layout of the illumination, which can lead to crosstalk to the keyboard matrix. The new index 82 keyboard with new layout fixed the problem.

The workaround at the right (Revision A cable) will fix it for the older index 00/81 boards → cutting the illumination supply on cable pins 5 and 6
