Vista and D950 Service News July 2008

Reliability of Motor Faders in D950 M2 and Vista 6, 7, 8

1 FADER CARE (VALID FOR ALPS FADERS 1.950.044)

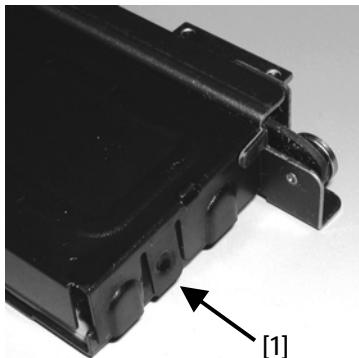
- [1] Carefully remove the cover by lifting the latch at the end opposite from the motor.
