# Customer Service BULLETIN

**22985**

**Title** Package update LDX Series

**Product** LDX Series

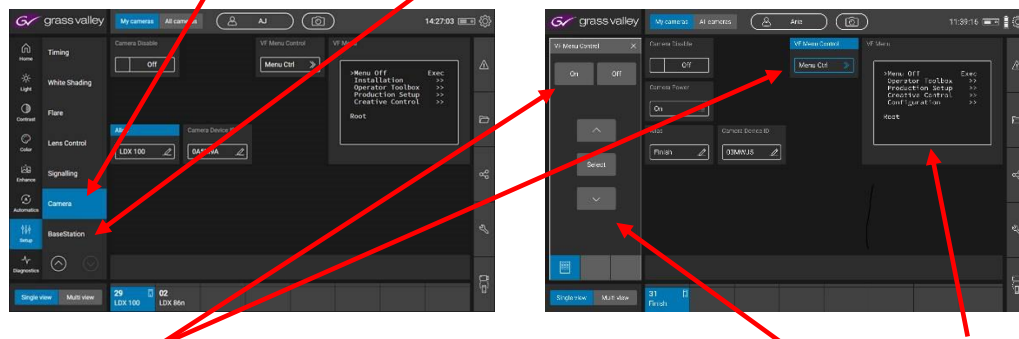
- Menu control of Camera/XCU available in the App  
(via Setup > Camera or Setup > Basestation)

Once “Menu Ctrl” is selected, the Camera/XCU menu can be controlled (and is visible) via the App. It can also be controlled via the CGP rotary/push button.

Note that, when selected, the menu becomes visible in the camera viewfinder and the XCU monitoring outputs as well.
