Sony Corporation

No. HDCM14-063R4-TN

Technical News

Subject: How to fix and improve Power Supply Unit broken by Abnormal Cable or sequentially pressed CAM PW Button

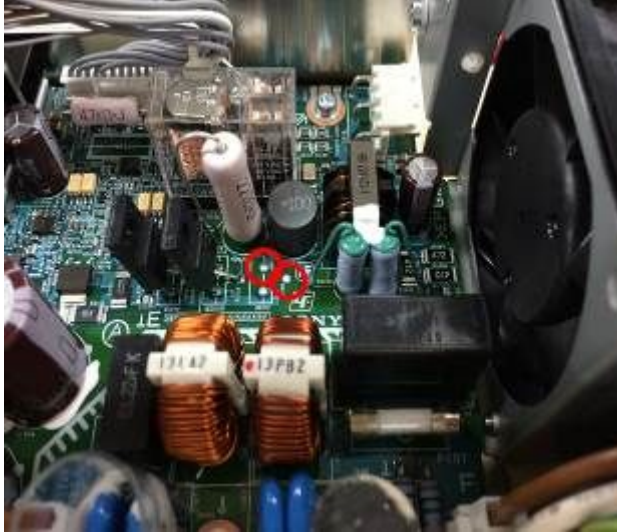
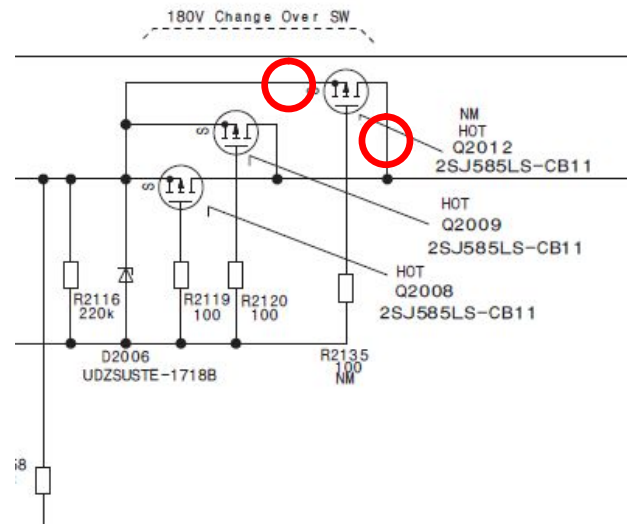
6. Replacement of FET

Measure the resistance between the source and the drain of the Q2012 on PS-778 board by the circuit tester.

In case of the normal board, it is about 200k Ω . In case it is almost short circuit, Q2008 or Q2009 is broken by shorting, replace them with the ones in the table below. It is not possible to specify either part is broken. The circuit is still short even after one FET is replaced, replace the other FET also.

Part No.	Part Name	Qty	Ref
8-729-054-30	TRANSISTOR 2SJ585LS-CB11	1 or 2	Q2008, Q2009 (either one, or both)
