Release Notes

Release 5.8.2

Version: 1.16

Date: 18.10.2018

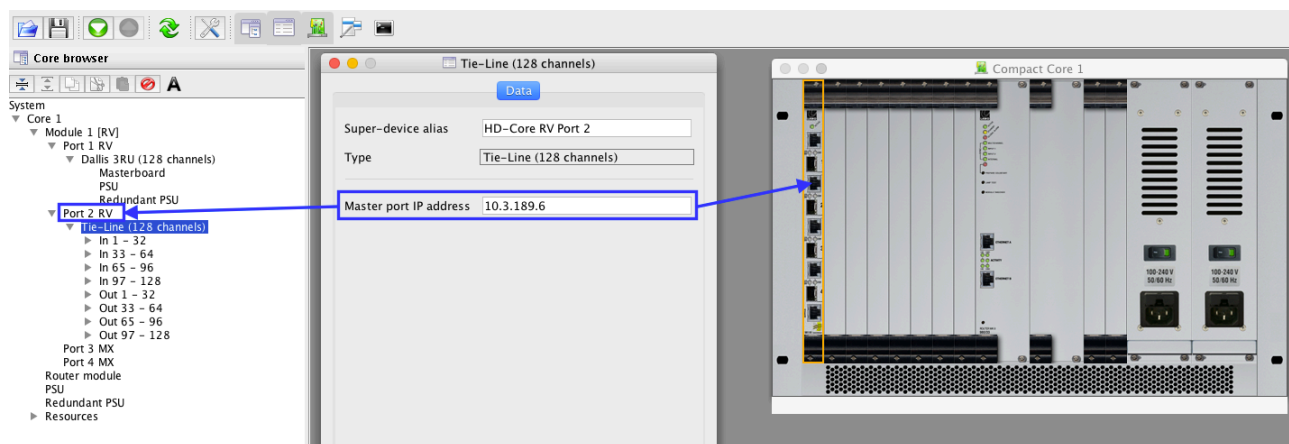
Starting from Version 5.8.2.14, we changed the streaming advertisement from Bonjour to RTSP. This has been done, to ensure proper operation in L3 network environments.

Therefore, please make sure to fill in the so called “Master port IP address” in AdminHD. This IP address is the one you would like to assign to your particular HD-Core RAVENNA port. Please be aware, that this IP address will not yet be transferred to the port automatically (please adjust the IP address using the Butler web-page), but is necessary to ensure RTSP operation.
