REPLACEMENT OF DRIED CAPACITORS ON TSI1000 MOTHERBOARD

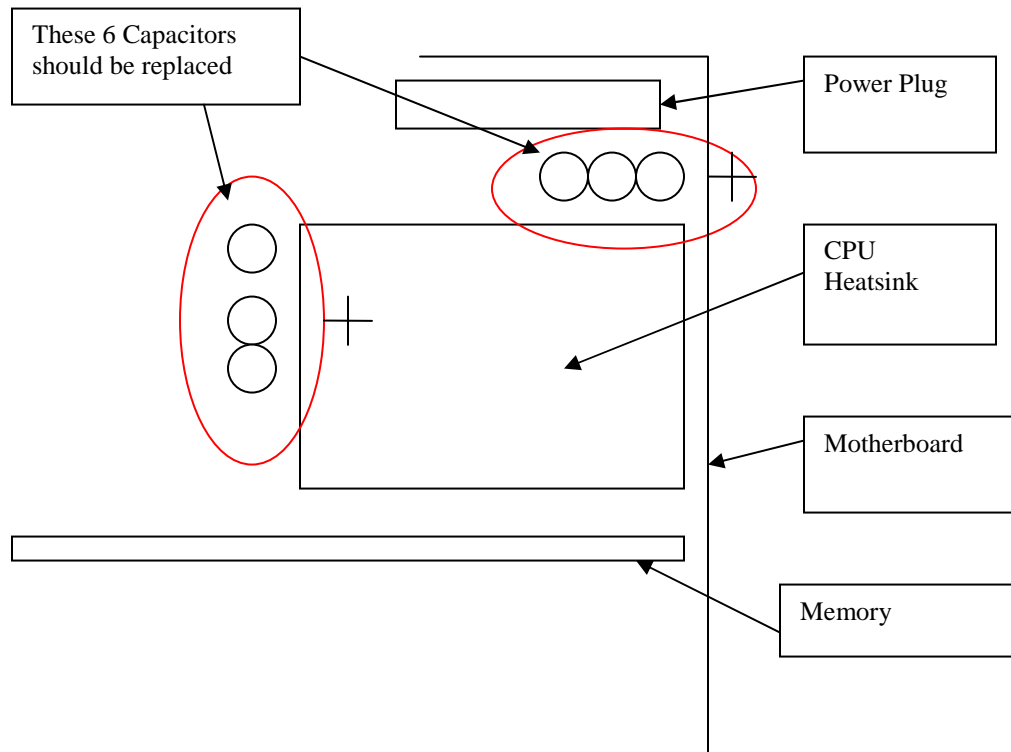
Note: Stripe on Capacitor marks negative side.
Positive side is marked on motherboard at each capacitor position.
