**Title:** Audio Input Cable Connector Installation

**Products:** Lynx, RM4000, RM5000 Audio Routing Switchers

**Date:** March 29, 1999

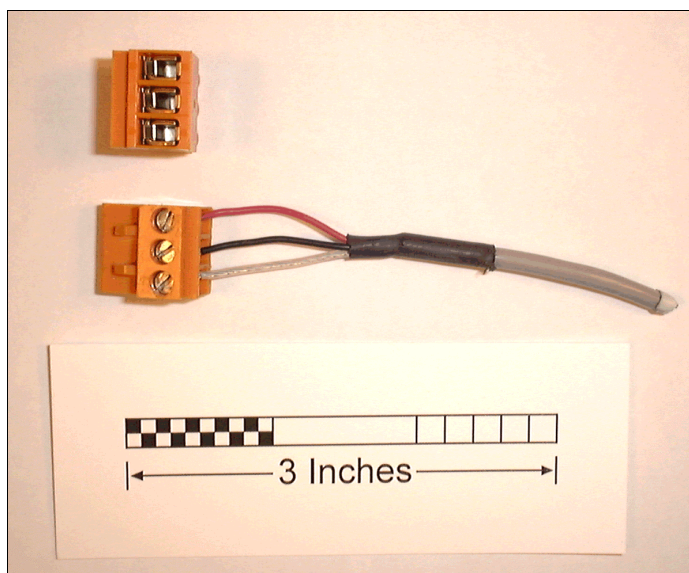
**Figure 1. Audio Input Cable Connector Installation**

Audio input cables are terminated with a 3-contact plug (PESA Part. No. 81-9029-0607-2) as shown in Figure 1. The connector contacts are not marked so the connector should be wired in accordance with Table 1.

Fig. 1 Position	Wire Color	Function
Top	Red	Audio High
Center	Black	Audio Low
Bottom	Shield	Shield
