# Broadcast Products Technical Bulletin 20-2007-092

SUBJECT: AUDIO CLICKING NOISE

MODEL: *HDC1500//UL***DESCRIPTION**

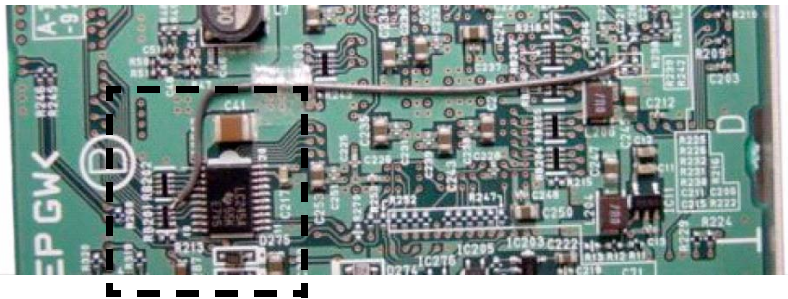
Figure 1

Audio clicking noise may occur in MIC audio output.

DAP-33 BOARD  
SUFFIX -12  
SIDE B, ZONE D-3

If the jumper on the DAP-33 board (suffix -12) is attached to RB202 instead of RB201, reattach the jumper to RB201. (See Figure 1.)

Confirm that noise does not occur in MIC audio output.
