## D/A Converter 1.949.688.00

## Vista Service News July 2005

## Vista Service News November 2005

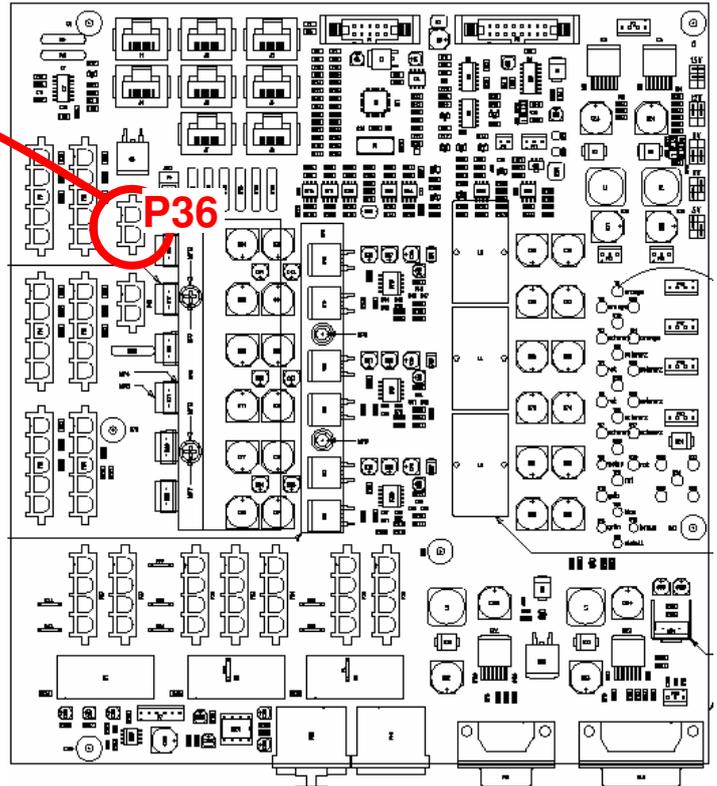
1.949.152.00 Distribution Board Redundant

The redundant PC of the Vista 8 is currently supplied from a single supply. In case of a defect supply of the redundant PC, not only the redundant system would fail, but also the main PC because signals are switched on the redundant distribution board.

The following connection with the main distribution board (1.949.150.81) provides a redundant 24V supply for the 1.949.152.00 board as well for the whole redundant PC.

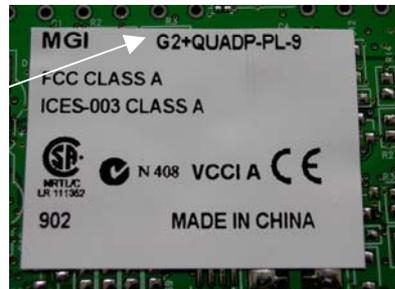
new version

There are 2 slightly different versions of the Matrox Quad Video Adapter cards in use for Vista systems.

The first generation systems were shipped with a Matrox "G2+/QUADP-PL", later systems were equipped with a "G2+/QUADP-PL-9" with new software drivers.

If 1st generation cards are replaced with the new type, or if a new image is restored to a Vista with the 1st generation cards, the operating system (Windows 2000) will recognize the mismatch of registered and installed card and will require some actions as described below.

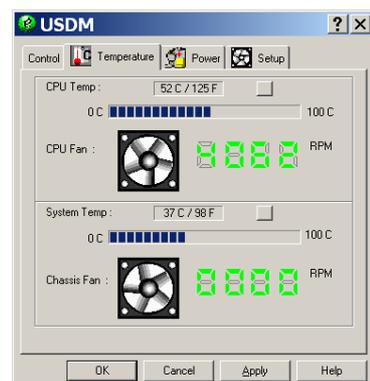
There was a known quality problem in 2002 which affected PC motherboards of different brands, due to problems of electrolytic capacitors from Taiwanese manufacturers. Refer to the following web pages for more detailed information about the 'capacitor plague' history, identification of the problem and replacement strategies :

- please be aware that there are many other reasons for booting and system stability problems (e.g. loss of BIOS data due to empty battery, temperature conditions or power supply). If there are no visual signs of the capacitor problems, the replacement is only one of many steps to be considered.

- a visual inspection of the motherboard should be done whenever there is a boot or freeze problem of the Vista PC system, a check is also recommended as a preventive step of regular maintenance. If there are any capacitors with bulged or domed tops (see examples above or on web links) or if there are any leaking capacitors, Studer can either provide suitable replacement capacitors (see following instruction), or can arrange a replacement of the board.

1000 uF  
6.3V / 105 °C  
(replace both with a single 2200 uF C)

The indicated capacitors (1000, 1500 and 2200 uF) should be replaced with high quality components with the same specifications. The Studer replacement kit includes 7 capacitors of 2200 uF for replacement of the original 1000, 1500 and 2200 uF ones (7 x 10.597.680.05)
