## D21 Mic/Line In Card

**1.949.427.00/81**

The input of The Mic/Line In Card may be damaged when phantom power is switched on and the input signal is short circuited. This may e.g. happen when using patch bays with connectors causing a temporary short circuit during the plugging of the connector (was reported from bantam connectors).

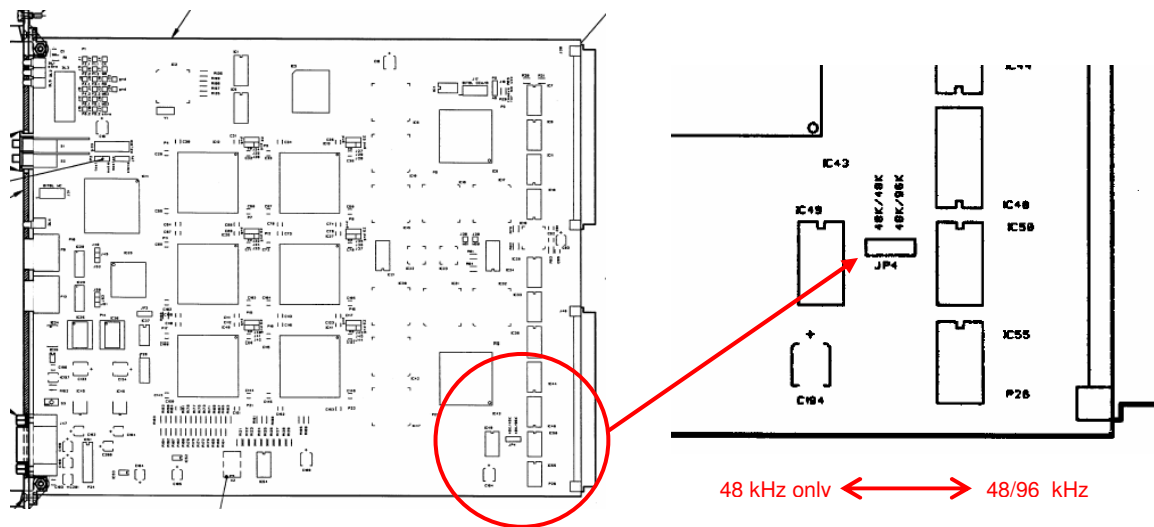
The PE21 DSP card can be configured to work with 48kHz sampling rate only, or allow 48/96 kHz operation. The mode is set with the indicated jumper JP4 :

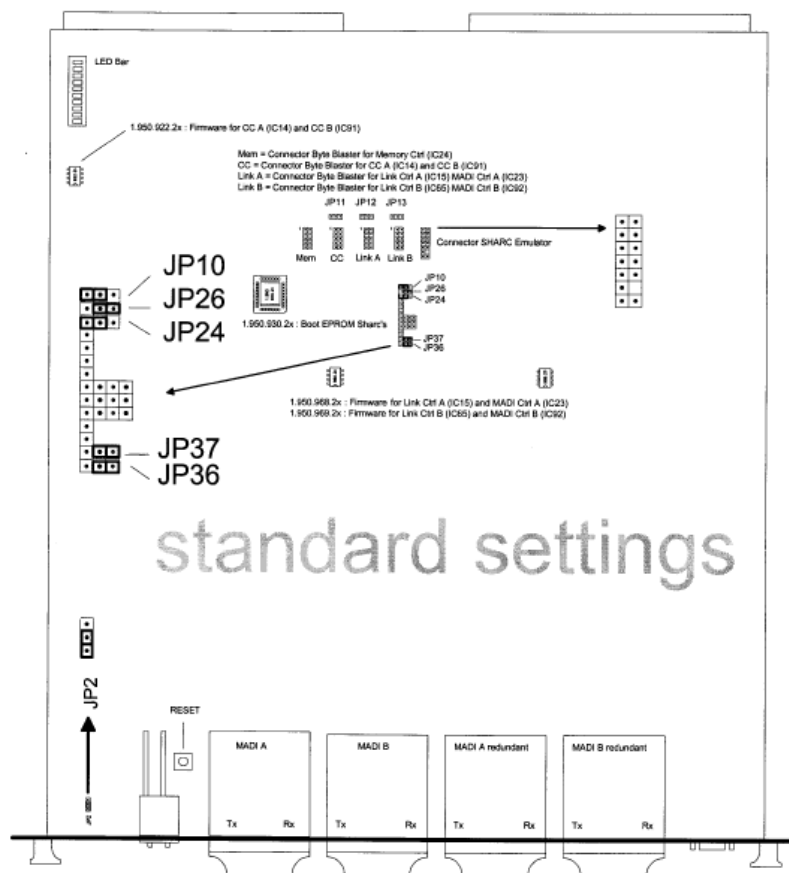
There are no user settings for operation, all settings are fixed as shown below. The position of JP2 is not important in standard operation.
