Appendix S

Status and Error Codes

VM/SI 3000 CONTROLLER BOARDS /

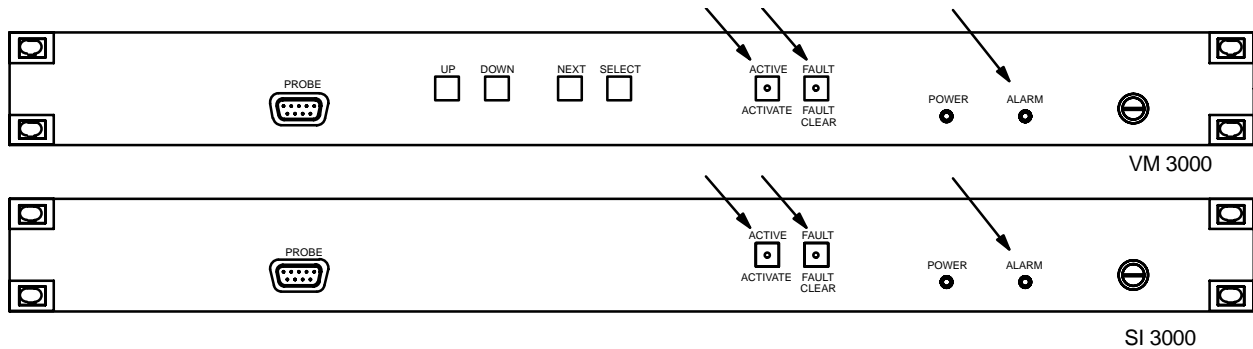
Current board status is reflected using the status LEDs on the front panel of the VM 3000 and SI 3000. The three main status LEDs on the front panel of the VM 3000 and SI 3000 are clearly marked (from left to right) “ACTIVE,” “FAULT,” and “ALARM.” On the VM 3000 and SI 3000, Alarm Relay contacts are on the rear panel. The LED and Relay functions are described in the table below.

Figure S-1. Board status indicators.

State	Active LED	Fault LED	Alarm LED	Alarm Relay	Description
STARTUP	ON	ON	ON	ON	Boot ROM code is running
LOADER	OFF	OFF	ON	ON	Check/Program lists, system
SYSTEM	OFF	ON	OFF	ON	Loader done, ready to start
STARTUP	ON	ON	OFF	ON	Starting applicable tasks
ACTIVE	ON	OFF	OFF	OFF	Board running, Active mode
STANDBY	OFF	OFF	OFF	OFF	Board running, Standby mode
FATAL	OFF	ON	ON	ON	Fatal error, board halted

Figure S-2. LED definitions.
