Multiple ADAMEdit / CSEdit Sessions

Communicating with an ADAM intercom system with up to three separate computers.

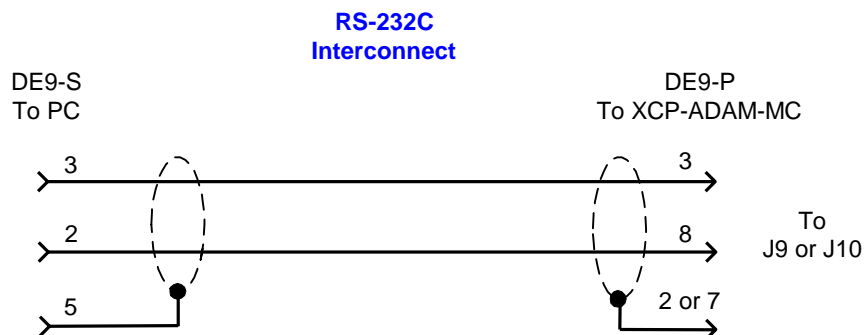
- Run ADAMEdit and go on-line.
- Select "OPTIONS"
- Select "COMMUNICATIONS"
- Select "ADVANCED" - **Must be connected to matrix to see this screen.**
- Then (Communication screen, Secondary ADAMEdit Sessions J9/J10)
- Advanced Settings (ADAM Only)

An ADAM Intercom System can communicate with up to 3 separate ADAMEdit sessions, all running on separate computers. Multiple sessions are not supported for ADAM CS or Zeus. To use this feature, you must configure the Advanced communications settings on the computer running the primary ADAMEdit session. This is the computer connected to J1 of the XCP-ADAM-MC Master Controller Breakout Panel. Second and third computers can then be connected to J9 and J10 of the Master Controller Breakout Panel.

Baud Rate: Select the highest baud rate that will work correctly. Unlike the baud rate setting for the primary ADAMEdit session, which is set by a master controller DIP switch, the baud rates for second and third computers are set in software, and there are no DIP switches.
