# Product Advisory - Hydra2 Hub - Patch Fix for CAL-16106

**NOTE:** This software patch only applies to Apollo and Artemis consoles running v7 software (ie: 7.0, 7.0.1 or 7.0.2) that feature one or more H2 Hubs (running Hydra2 v1.6f / v1.6f2 software).

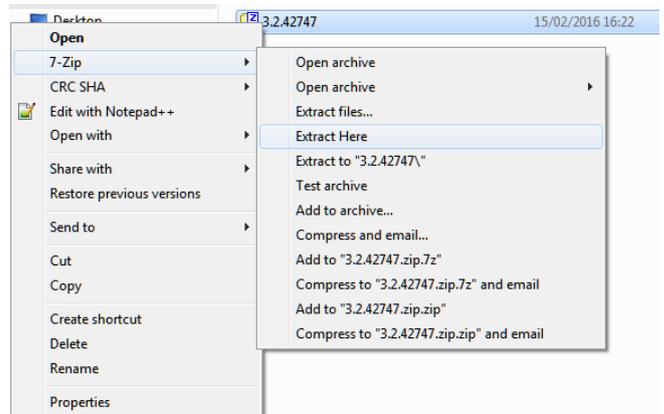
2. The patch is supplied as a zip file, with the file name **H2Hub Firmware CAL-16106 patch.zip**. Copy this file to the desktop of the console PC using a USB memory device.

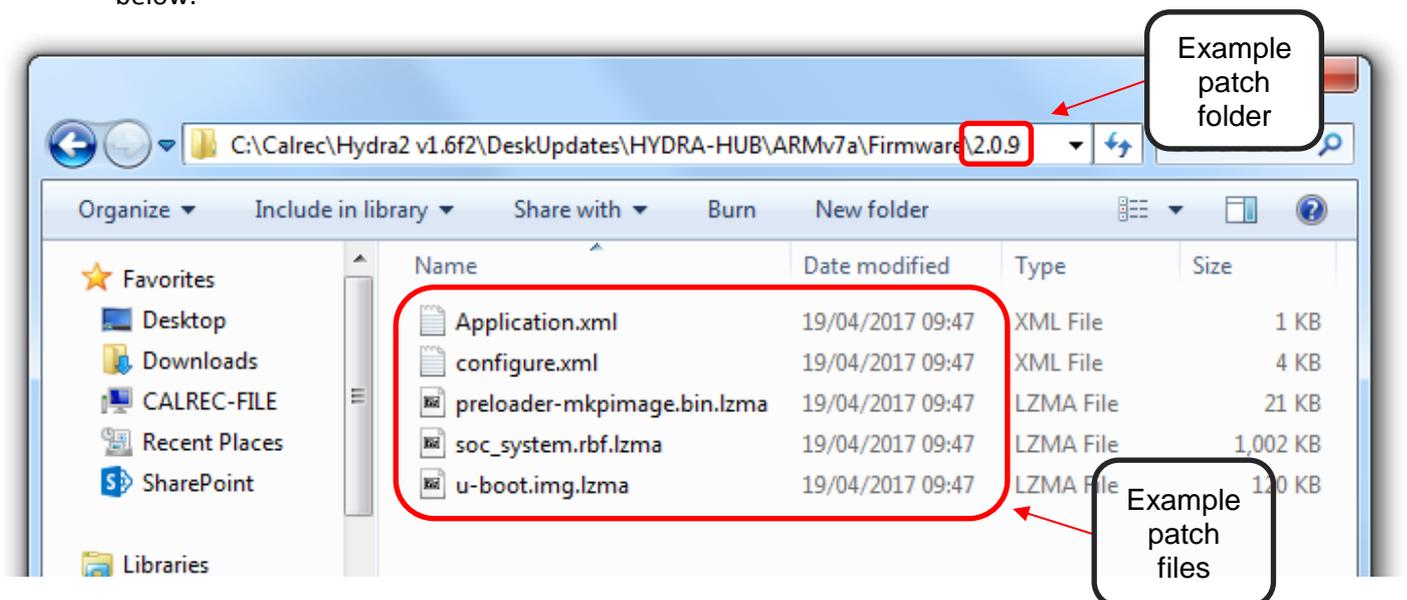
- You will notice that another similar folder (1.6.8) already pre-exists in this directory, there is no requirement to delete or change this folder.
- Once copied, open the **2.0.9** folder and ensure that the directory structure is the same as in the image below:

**C:\Calrec\Hydra2v1.6f\DeskUpdates\HYDRA\_HUB\ARMv7a\Firmware**

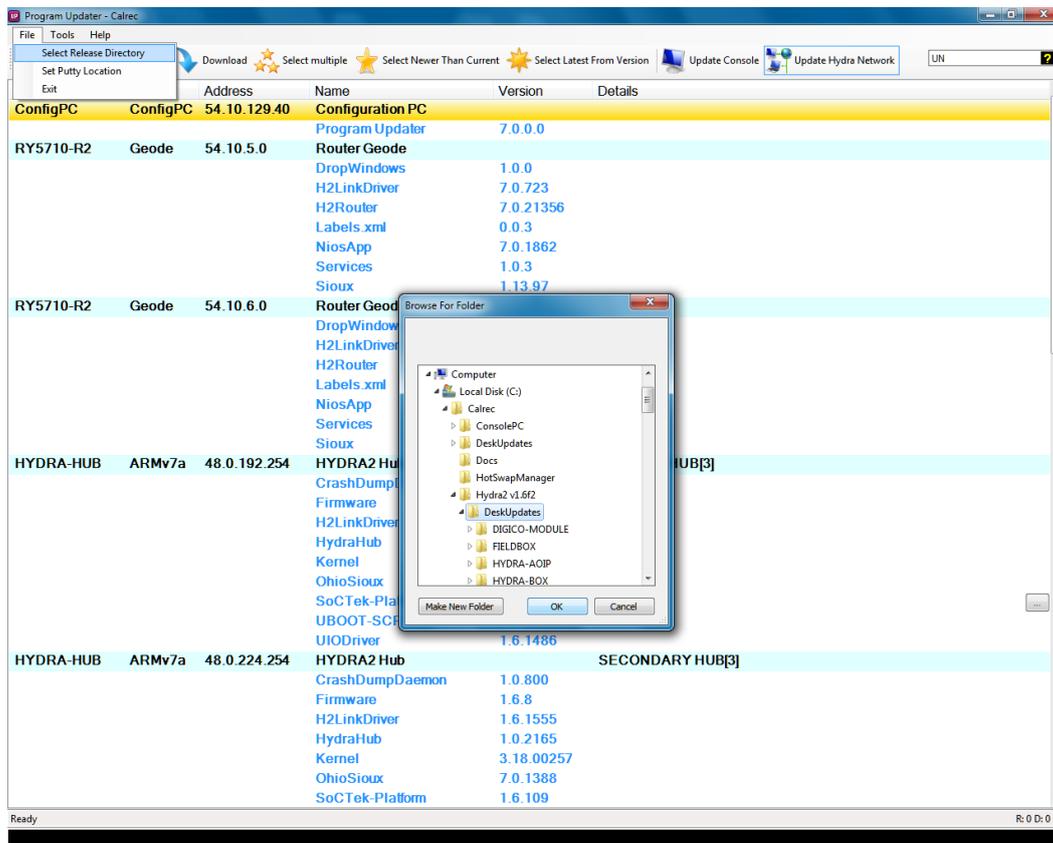
- 5. Close all open windows, then run the **Program Updater** application (from the desktop or start menu)
  - When Program Updater opens it will populate a list of all devices in the system. Please wait for this list to populate.
- 6. On the top menu bar, go to **File** then **Select Release Directory**. In the popup window make sure the following directory is selected, then click **OK**:

C:\Calrec\DeskUpdates\Hydra2 v1.6f\DeskUpdates

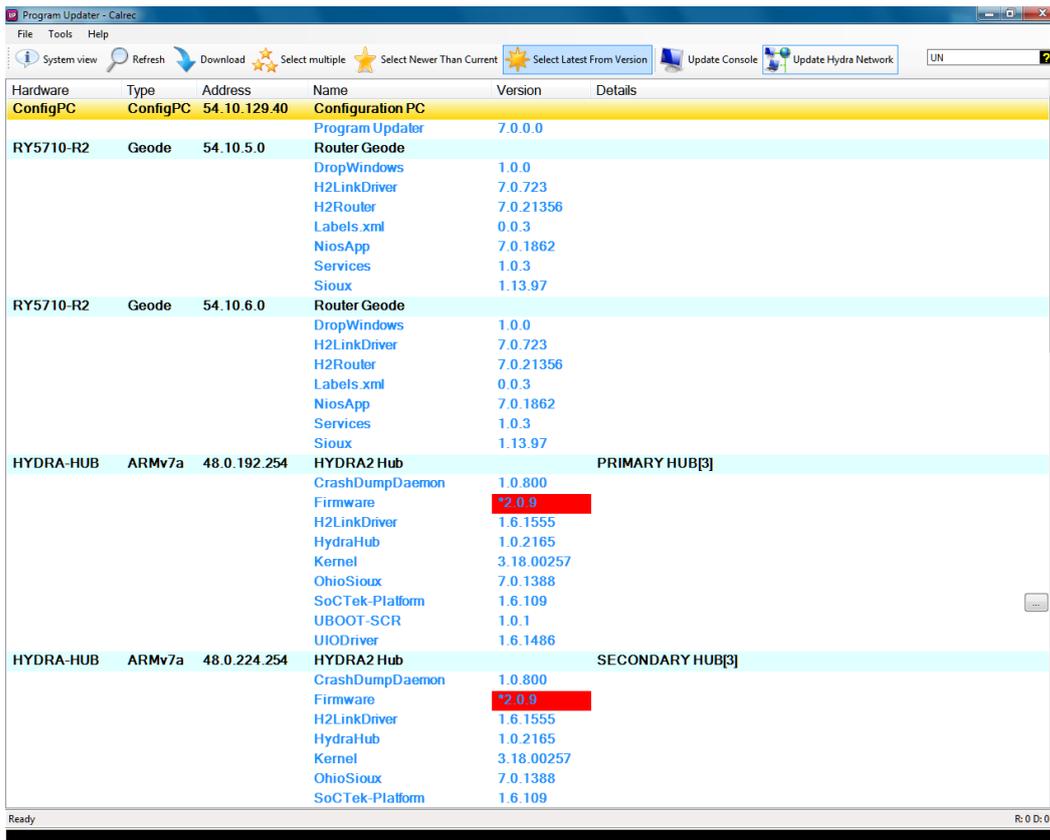
- This will cause Firmware component listed under the Hydra Hub to be highlighted red (both primary and secondary), as below:

10. Click on the button labelled **Select Latest From Version**

11. Click on the button labelled **Download**, the applications highlighted in red will now be updated. A green bar will display the progress of these upgrades:
