Multicam 08.03.12

Multicam 8.03.12 Release Notes

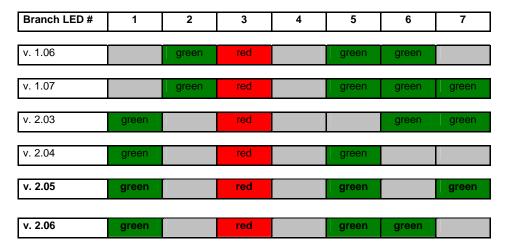
- SDTI Network in Multicam 08.03.12 is not compatible with previous versions. All systems in the network must run v. 08.03.12 to be able to connect. If a system has a wrong software version, an error message will be displayed when trying to connect to the network.
- Compatibility with XHub SDTI hub: Multicam 08.02.47 is only compatible with v. 2.05 or 2.06 of the XHub. If unsure, you can check the version with the following procedure:
 - o Turn off the hub
 - Move all 4 dip switches on the front panel to the lower position.
 - Turn on the hub
 - o The 7 branch status LEDs will light according a binary pattern, as described in the table below.

- o Turn off the hub
- o Move all 4 dip switches back to the upper position.
- o If you need to upgrade the hub, please contact EVS to get the upgrade software and procedure.
