Customer Service BULLETIN

23811

Title Package update LDX 100

Product LDX 100

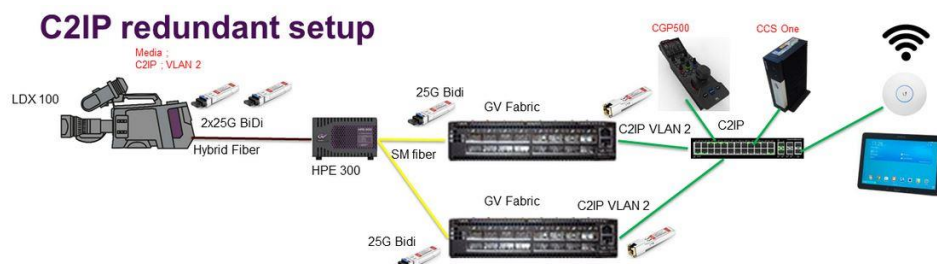
The block diagram below shows a typical redundant Media network setup with two Ethernet switches.

VLAN tagged ports are used to create a flow for the C2IP packets to a management switch, which is used for the camera control panels.

C2IP failover on primary/secondary Media network interface

When using C2IP control of the camera over VLAN on the Media network interface it is required that C2IP control from a control panel on the management network is still available when one of the two SFP28 Media network interfaces fails.

Because the control panels (CGP500 and CCS One) do not support redundancy the camera shall hard switch between the primary and secondary network interface for the C2IP Ethernet packets in case one of the interfaces fails.
