## Customer Service BULLETIN

**Customer Service Bulletin** 000018932

**Title** Package update LDX Series and XCU (3G and 10G Universe)

**Product** LDX Series

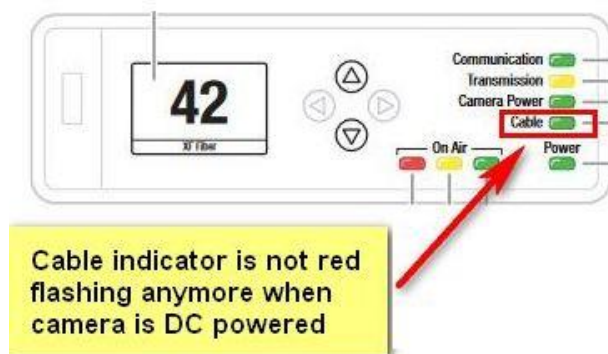
- Add system Alias to cradle storage.
- In case the camera is DC powered (Power box or in Direct IP mode) the cable indicator on the front panel of the XCU is not red flashing anymore as soon as transmission is established

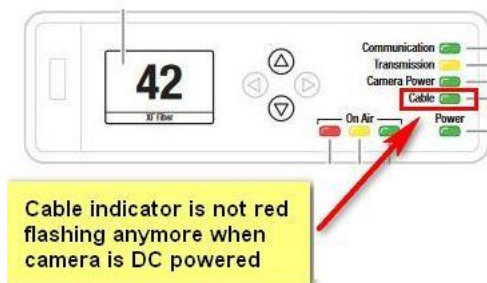
- Add system Alias to cradle storage.
- In case the camera is DC powered (Power box or in Direct IP mode) the cable indicator on the front panel of the XCU is not red flashing anymore as soon as transmission is established
