# GV NODE

IP AGGREGATION, PROCESSING AND EDGE ROUTING  
PLATFORM

## Release Notes

## Release Notes for GV Node

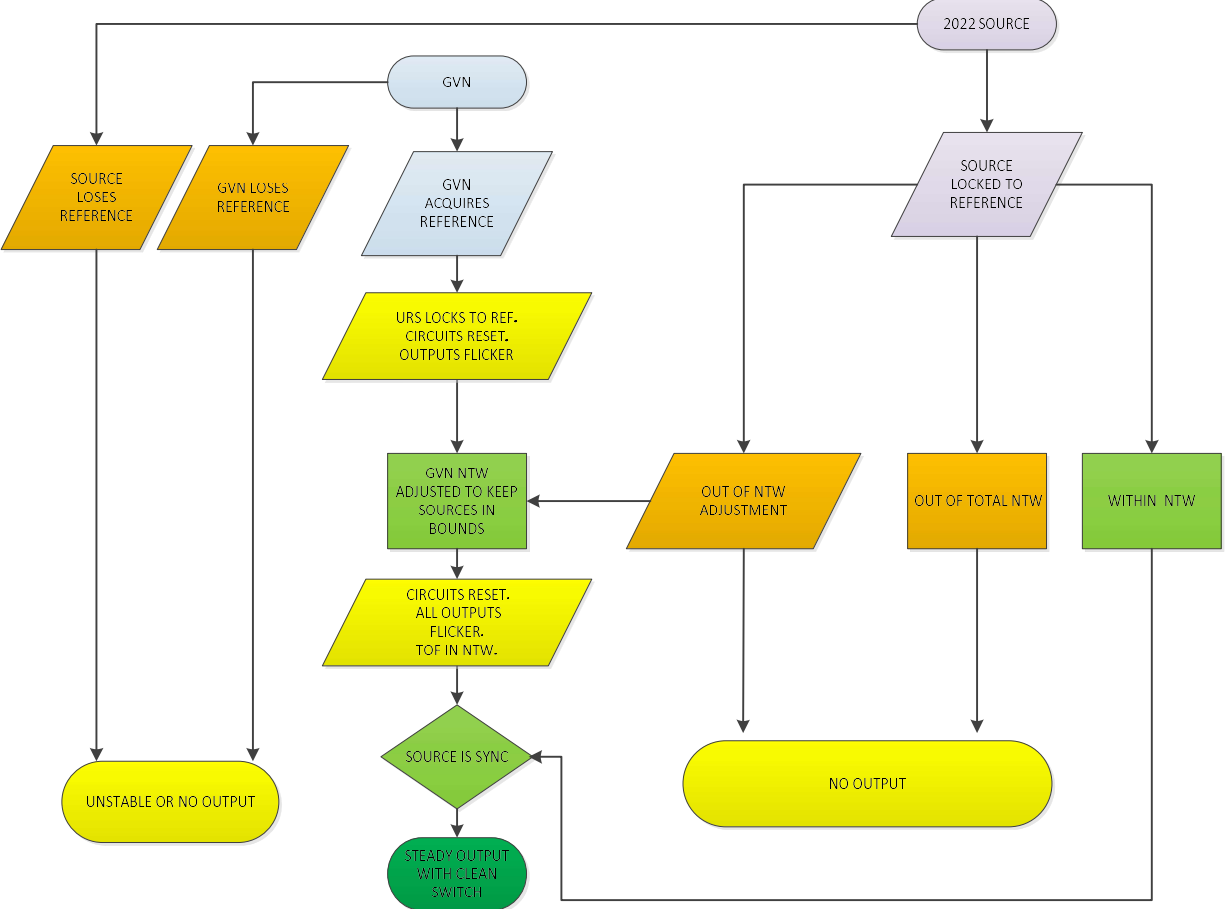
Ref #	Description
IFM-3395	<p><b>Does not support Asynchronous sources</b></p> <p>GVN V1.2 will not pass any signal whose TOF (Top Of Frame) is outside of NTW (Network Tolerance Window). If it is within NTW, the signal will pass and can be clean switched. If the source is free-running, it may pass at times, but will cause flashes, when the circuit needs to reset to relock.</p> <p>Reference lock and timing adjustment are used to keep signal TOF in NTW.</p>

<pre> graph TD     Source([2022 SOURCE]) --&gt; L1(( ))     L1 --&gt; Sloses[SOURCE LOSES REFERENCE]     L1 --&gt; GVN((GVN))     GVN --&gt; GVNloses[GVN LOSES REFERENCE]     GVN --&gt; GVNacq[/GVN ACQUIRES REFERENCE/]     Sloses --&gt; Unstable([UNSTABLE OR NO OUTPUT])     GVNloses --&gt; Unstable     GVNacq --&gt; URS[/URS LOCKS TO REF. CIRCUITS RESET. OUTPUTS FLICKER/]     URS --&gt; GVNNTW[GVN NTW ADJUSTED TO KEEP SOURCES IN BOUNDS]     GVNNTW --&gt; CReset[/CIRCUITS RESET. ALL OUTPUTS FLICKER. TOF IN NTW./]     CReset --&gt; Sync{SOURCE IS SYNC}     Sync --&gt; Steady([STEADY OUTPUT WITH CLEAN SWITCH])     Sync --&gt; NoOutput([NO OUTPUT])     Source --&gt; Locked[/SOURCE LOCKED TO REFERENCE/]     Locked --&gt; OutNTW[/OUT OF NTW ADJUSTMENT/]     Locked --&gt; OutTotal[OUT OF TOTAL NTW]     Locked --&gt; Within[WITHIN NTW]     OutNTW --&gt; NoOutput     OutTotal --&gt; NoOutput     Within --&gt; Steady </pre>
