Kaleido-X

Version 6.70

Release Notes

M770-2103-135

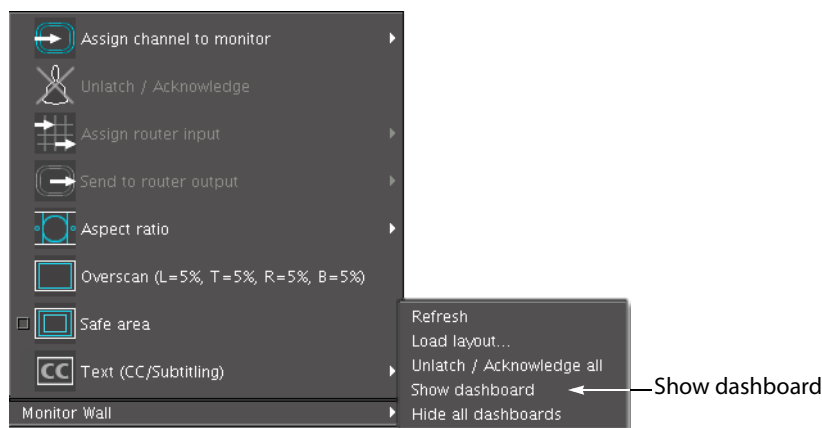
Monitor wall shortcut menu (within composite monitor shortcut menu)

- 1 Right-click anywhere on the monitor wall. On the shortcut menu, point to **Monitor Wall**, and then click **Show dashboard** to display the dashboard associated with the current head.

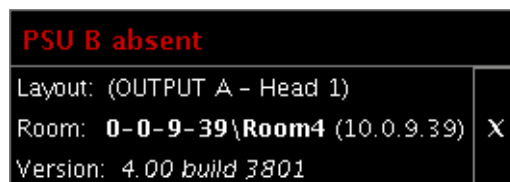
Dashboard on the monitor wall

After a brief delay, the dashboard appears at the bottom-right corner of the monitor, and the command **Hide dashboard** replaces **Show dashboard** on the menu.
