KALEIDO-X

Version 8.42

Release Notes

M770-2103-170

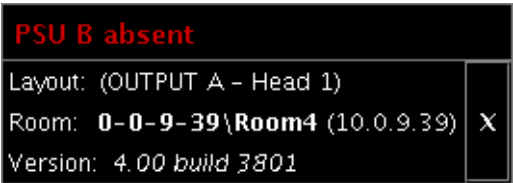
Dashboard on the monitor wall

After a brief delay, the dashboard appears at the bottom-right corner of the monitor, and the command **Hide dashboard** replaces **Show dashboard** on the menu.
