KALEIDO-X

VERSION 8.30

Release Notes

M770-2103-166

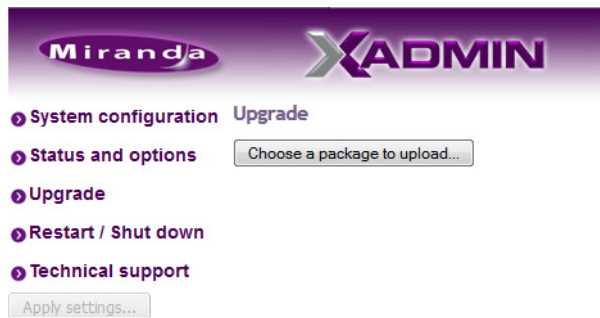
- 3 Click **Upgrade**, in the navigation area on the left of the page.

The Upgrade page appears.

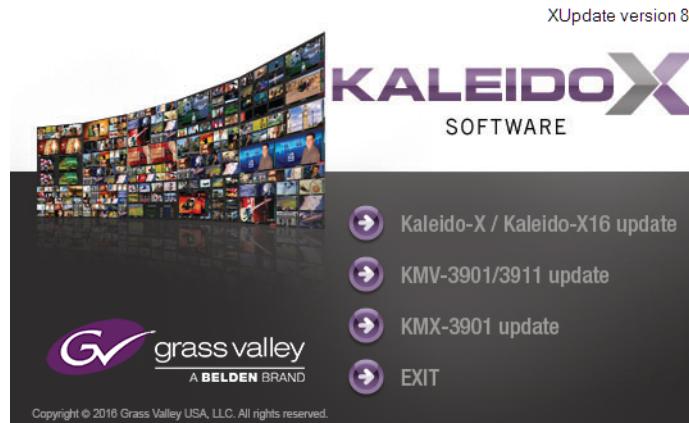
- 4 On the startup screen, click the appropriate update option for your multiviewer model:

- **Kaleido-X / Kaleido-X16 update**, for a Kaleido-X or Kaleido-X16 multiviewer
- **KMV-3901/3911 update**, for a Kaleido-Modular KMV-3901 or KMV-3911 multiviewer, or for a Kaleido-XQUAD
- **KMX-3901 update**, for a Kaleido-MX, Kaleido-MX 4K, or Kaleido-Modular-X multiviewer

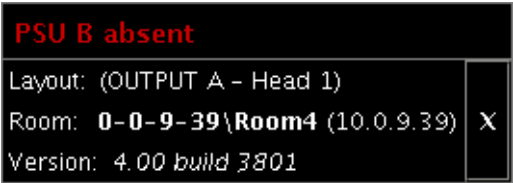
Dashboard on the monitor wall

After a brief delay, the dashboard appears at the bottom-right corner of the monitor, and the command **Hide dashboard** replaces **Show dashboard** on the menu.
