# **KALEIDO-X**

VERSION 8.40

## **Release Notes**

M770-2103-168

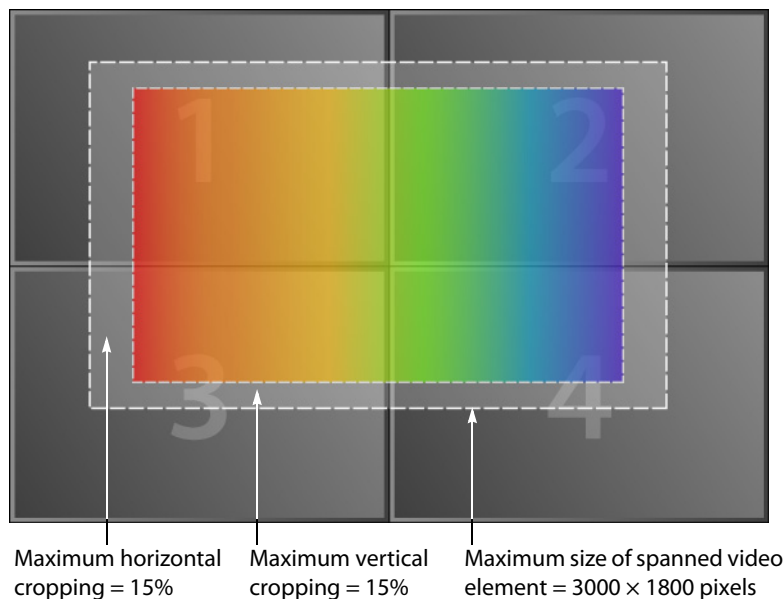
- [Ref. #KX-2270] **Kaleido-X, Kaleido-X16:** Excessive scaling of video elements results in a loss of video image on a monitor wall. This can be caused by loading a complex layout with a video monitor or full screen zone spanning two or more displays. The problem can be made worse by overlapping elements.  
*Workaround:* Keep full screen zones within a single display. Do not span a monitor beyond a maximum of 3000 × 1800 pixels. When spanning or scaling video monitors in a layout, avoid heavy cropping settings (generally avoid exceeding 15% in any direction). If the problem persists in full screen layouts, try reducing the scaling settings further.

**Note:** Even if a spanned video monitor does not exceed the recommended maximum size, the problem could occur if it is set to follow AFD/WSS with a custom cropping of (15, 15, 15, 15).

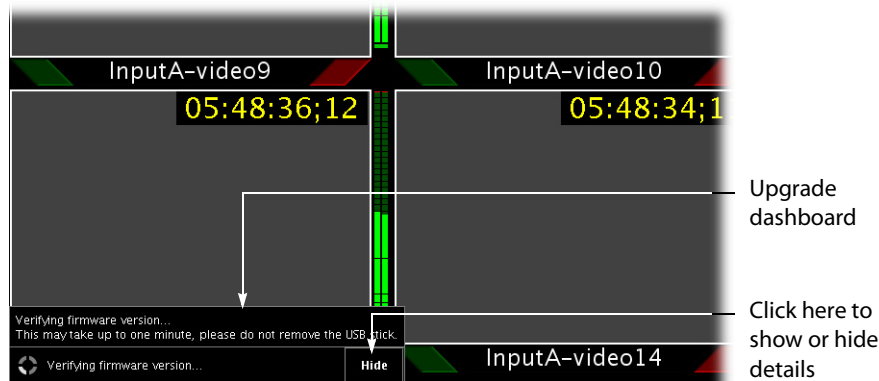
- 1 Insert the USB key into any USB port on the multiviewer. After a while, a message appears at the bottom left corner of the monitor wall, reporting that the Upgrade Manager is verifying software, firmware, and safe mode versions.

**Note:** You can click the **Details** button to view more information. The button label alternates between **Details** and **Hide**.

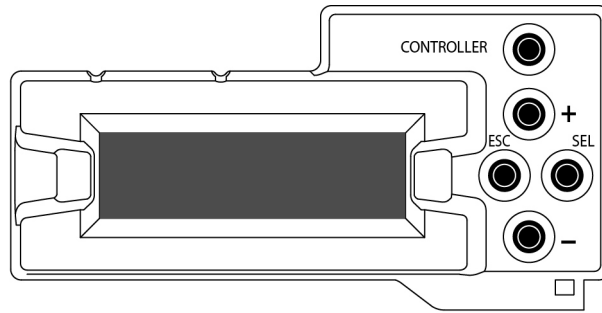
- 1 On the Densité frame's local control panel, press the CONTROLLER button.

- 2 Press the [-] button repeatedly until RESTORE POINTS appears on the display, and then press the SEL button.
- 3 Press the [-] button repeatedly until DEFAULT ACTION appears on the display, and then press the SEL button.
  - If the control panel's display shows KEEP SETTINGS, then the automatic restore feature is already disabled.
  - If the control panel's display shows UPDATE SETTINGS, navigate to KEEP SETTINGS by pressing the [+] button, and then press the SEL button to apply your change.
- 4 Press the CONTROLLER button to exit the controller's menu.

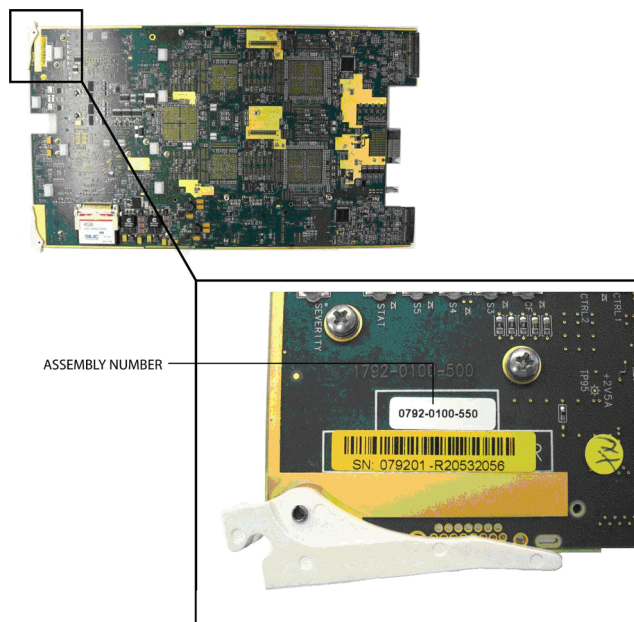
All Kaleido-X output cards with assembly numbers 0792-2800-601 and above (KXO-Dual3), or between 0792-0100-563 and 0792-0100-571 (KXO-Dual) have a 2-GB RAM module factory-installed. To find the assembly number for an output card, look at the underside of the board near the bottom ejector. The assembly number is printed on a small white label:

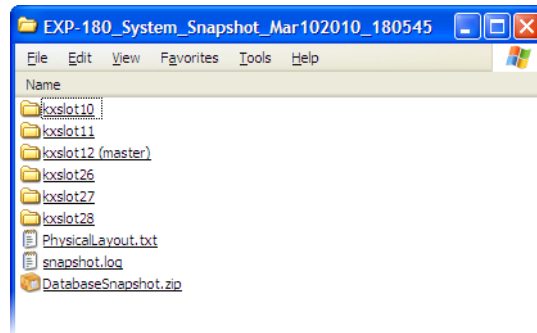
- 1 Open XAdmin's Technical Support page, to download a system snapshot (see "Generating a System Snapshot" in the Kaleido-X User's Manual), and then extract the content of the ZIP file to a folder on your local hard drive.
- 2 Open the folder where you extracted the system snapshot, and notice that it contains a number of subfolders whose name starts with "kxslot". There is one such folder for each output card. For example, the system snapshot folder for an expansion system with six output cards would look like this:

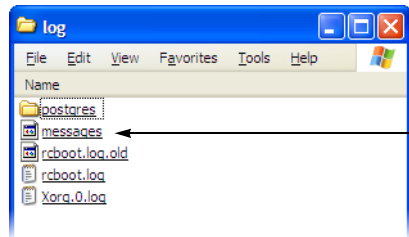
- 4 Open the folder you just identified, and navigate to `/var/log/messages`:

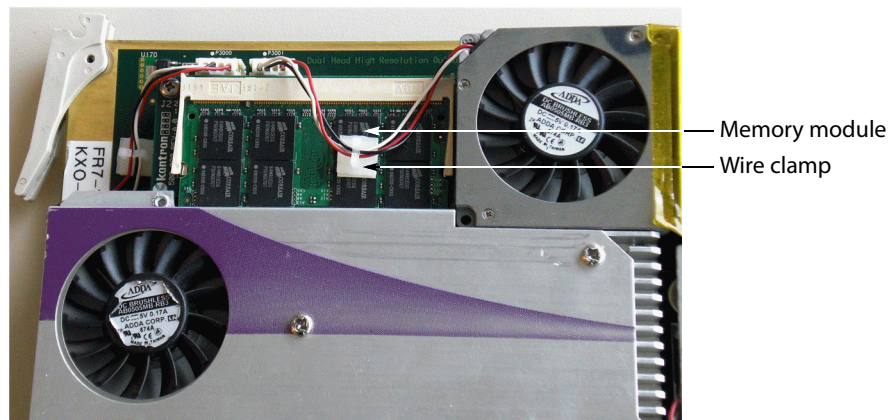
- 1 Remove the KXO-Dual card from the Kaleido-X system.
- 2 Locate the memory module near the front edge of the card in the corner that is enclosed by two fans:

- 3 If there is a plastic clamp holding fan wires glued on top of the memory module, carefully release the wires from the clamp.
- 4 Release the two retaining clips holding the memory module in place.
- 5 Pull the memory module away from the card at a 45 degree angle.

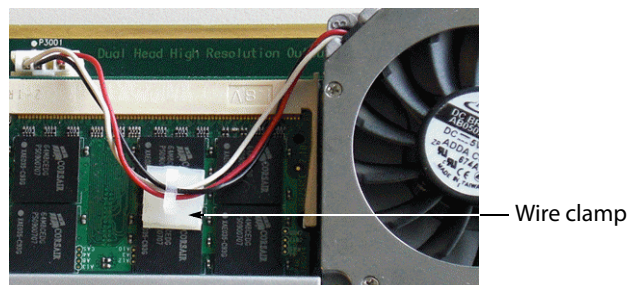
- 1 Insert the replacement memory module at a 45 degree angle.
- 2 Carefully press the memory module down so that the retaining clips lock into place.
- 3 Attach the self-adhesive wire clamp (part no. 2400-0040-0) to the top of the memory module, and carefully secure the fan wires as shown below:

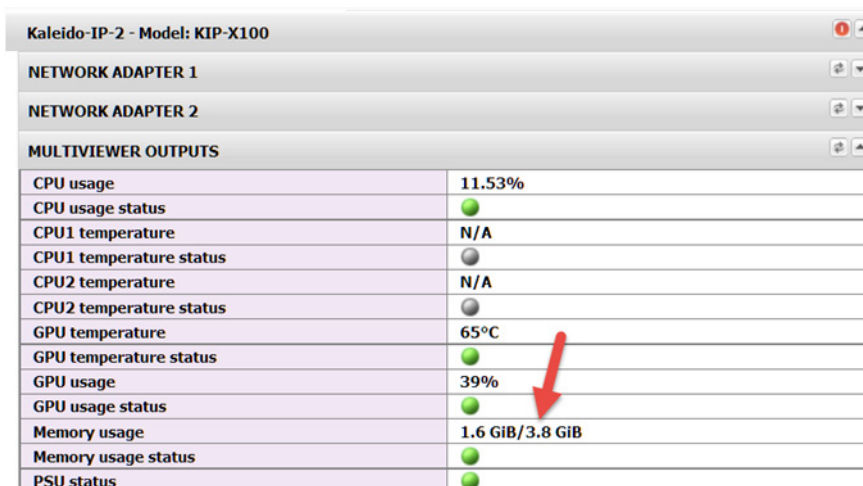
- 1 Open XAdmin's Status and Options page.
- 2 Expand the MULTIVIEWER OUTPUTS section.

Kaleido-IP 2 - Model: KIP-X100	
NETWORK ADAPTER 1	
NETWORK ADAPTER 2	
MULTIVIEWER OUTPUTS	
CPU usage	11.53%
CPU usage status	<span style="color: green;">●</span>
CPU1 temperature	N/A
CPU1 temperature status	<span style="color: gray;">●</span>
CPU2 temperature	N/A
CPU2 temperature status	<span style="color: gray;">●</span>
GPU temperature	65°C
GPU temperature status	<span style="color: green;">●</span>
GPU usage	39%
GPU usage status	<span style="color: green;">●</span>
Memory usage	1.6 GiB/3.8 GiB
Memory usage status	<span style="color: green;">●</span>
PSU status	<span style="color: green;">●</span>

- 3 The value indicated next to **Memory usage** has the following format: <currently used memory>/<total available memory>.
- 4 If the total available memory indicated is less than the minimum requirements for your Kaleido-IP model and monitoring purposes, then you need to order the appropriate memory upgrade option.

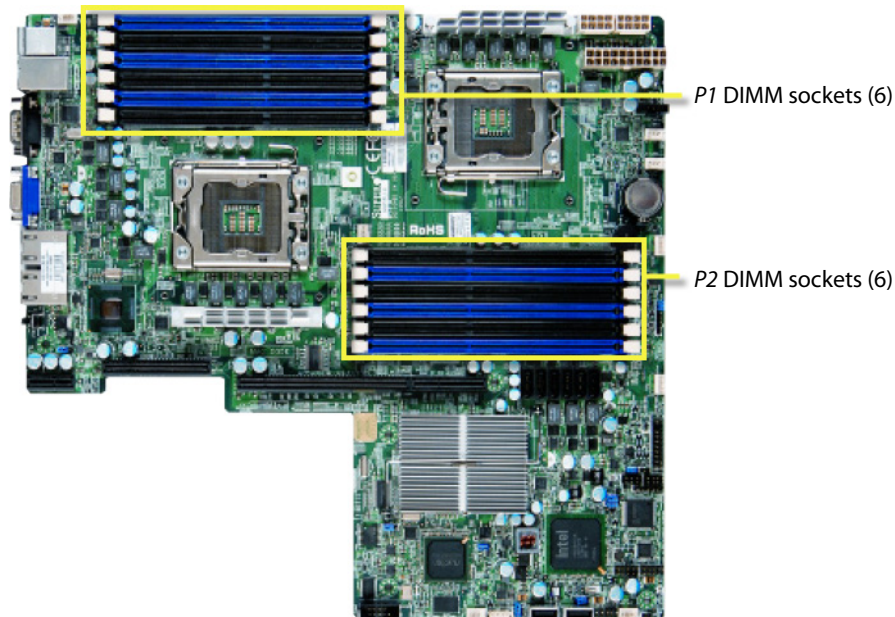
*Picture of the X300 motherboard, from X8DTU/X8DTU-F User's Manual, Revision 1.20*

- 3 Open the frame, and locate the 12 DIMM sockets on the motherboard.

- 4 For each memory module currently on the board:
  - a Use your thumbs to push the release tabs near both ends of the module. This should release the module from the slot.
  - b Pull the module away from the board, vertically.
- 5 In each of the 6 *blue* DIMM socket on the board:
  - a Insert a 4-GB memory module vertically, making sure to align the notch at the bottom of the module with the socket's corresponding point.
  - b Carefully press the memory module down so that the retaining tabs lock into place.
- 6 Connect the power cords, and then turn the power on.  
The power switch is located on the front panel.
