KALEIDO-X

Version 8.52

Release Notes

M770-2103-173

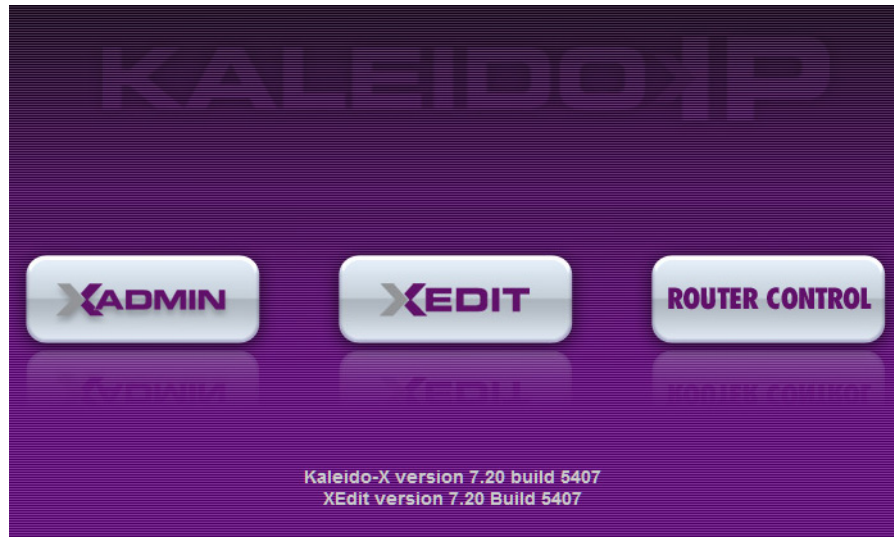
- 1 From a workstation on the same subnet, open a Web browser window, and type the *management* IP address of the multiviewer, in the address bar.
The Kaleido-IP home page appears.

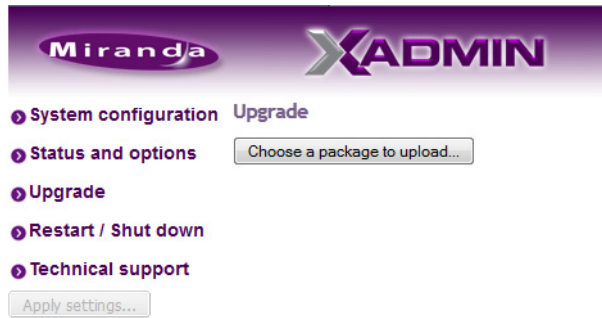
The Upgrade page appears.

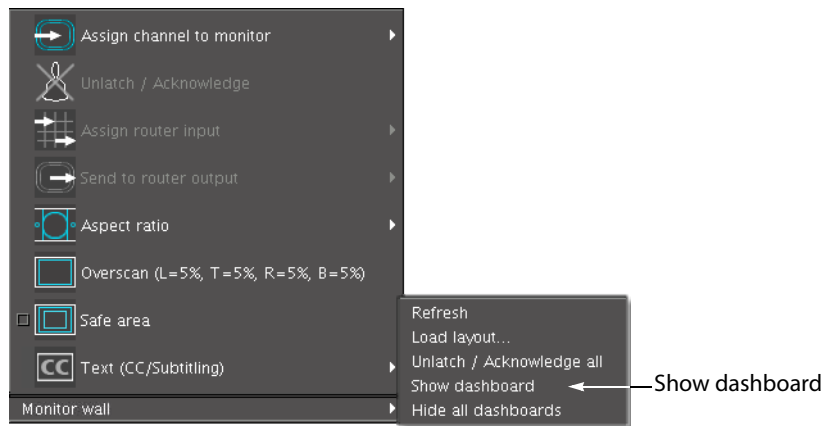
Monitor wall menu (within composite monitor menu)

- 1 Right-click anywhere on the monitor wall. On the menu, point to **Monitor wall**, and then click **Show dashboard** to display the dashboard associated with the current head.

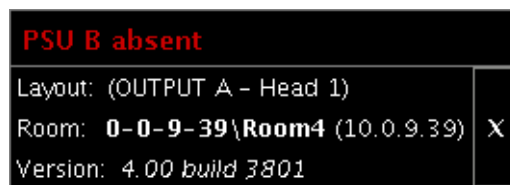
Dashboard on the monitor wall

After a brief delay, the dashboard appears at the bottom-right corner of the monitor, and the command **Hide dashboard** replaces **Show dashboard** on the menu.

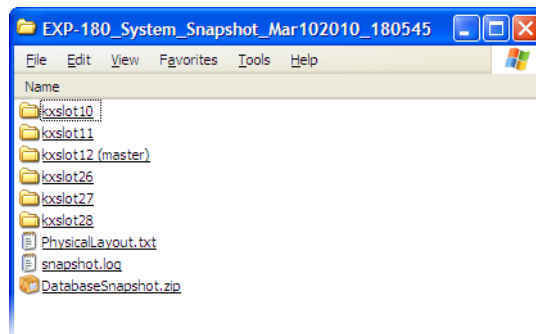
- 1 Open XAdmin’s Technical Support page, to download a system snapshot (see “Generating a System Snapshot” in the Kaleido-X User’s Manual), and then extract the content of the ZIP file to a folder on your local hard drive.
- 2 Open the folder where you extracted the system snapshot, and notice that it contains a number of subfolders whose name starts with “kxslot”. There is one such folder for each output card. For example, the system snapshot folder for an expansion system with six output cards would look like this:
