# **KALEIDO-X**

VERSION 7.80

## **Release Notes**

M770-2103-155

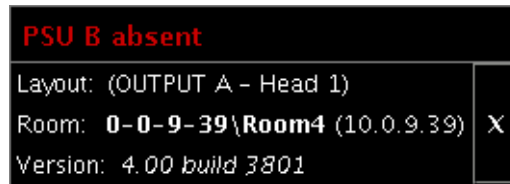
*Dashboard on the monitor wall*

After a brief delay, the dashboard appears at the bottom-right corner of the monitor, and the command **Hide dashboard** replaces **Show dashboard** on the menu.
