KALEIDO-X

VERSION 7.82

Release Notes

M770-2103-158

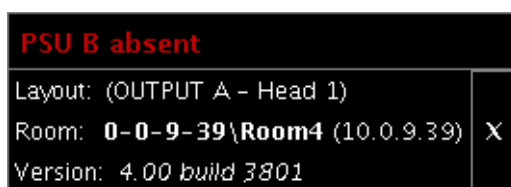
Dashboard on the monitor wall

After a brief delay, the dashboard appears at the bottom-right corner of the monitor, and the command **Hide dashboard** replaces **Show dashboard** on the menu.

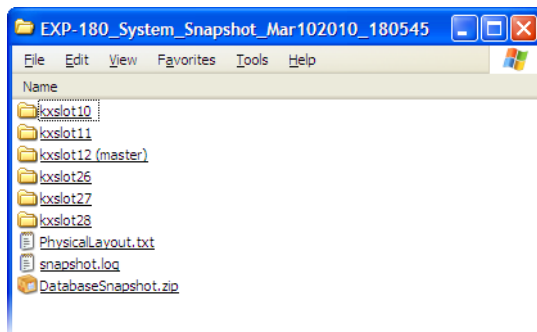
- 1 Open XAdmin's Technical Support page, to download a system snapshot (see "Generating a System Snapshot" in the Kaleido-X User's Manual), and then extract the content of the ZIP file to a folder on your local hard drive.
- 2 Open the folder where you extracted the system snapshot, and notice that it contains a number of subfolders whose name starts with "kxslot". There is one such folder for each output card. For example, the system snapshot folder for an expansion system with six output cards would look like this:

- 3 Referring to the tables below, identify which *kxslot* folder corresponds to the output card whose RAM capacity you wish to verify:
