KALEIDO-X

VERSION 7.83

Release Notes

M770-2103-159

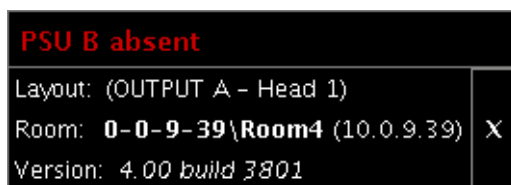
Dashboard on the monitor wall

After a brief delay, the dashboard appears at the bottom-right corner of the monitor, and the command **Hide dashboard** replaces **Show dashboard** on the menu.

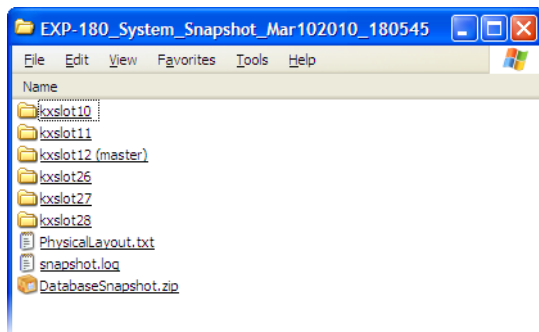
- 1 Open XAdmin's Technical Support page, to download a system snapshot (see "Generating a System Snapshot" in the Kaleido-X User's Manual), and then extract the content of the ZIP file to a folder on your local hard drive.
- 2 Open the folder where you extracted the system snapshot, and notice that it contains a number of subfolders whose name starts with "kxslot". There is one such folder for each output card. For example, the system snapshot folder for an expansion system with six output cards would look like this:
