# **KALEIDO-X**

VERSION 8.20

## **Release Notes**

M770-2103-165

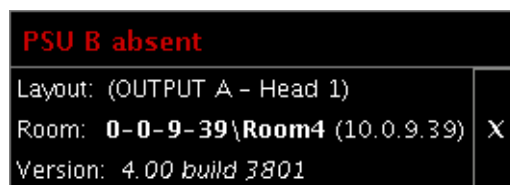
Dashboard on the monitor wall

After a brief delay, the dashboard appears at the bottom-right corner of the monitor, and the command **Hide dashboard** replaces **Show dashboard** on the menu.
