Release Title:	RTS-ROAMEO Release v8.6.0
Release Date:	08-June-2021
Version:	8.6.0

The following instructions explain how to setup and configure a ROAMEO AP-1800 access point (AP) and TR-1800 beltpack (BP) to begin communicating with the Matrix over OMNEO.

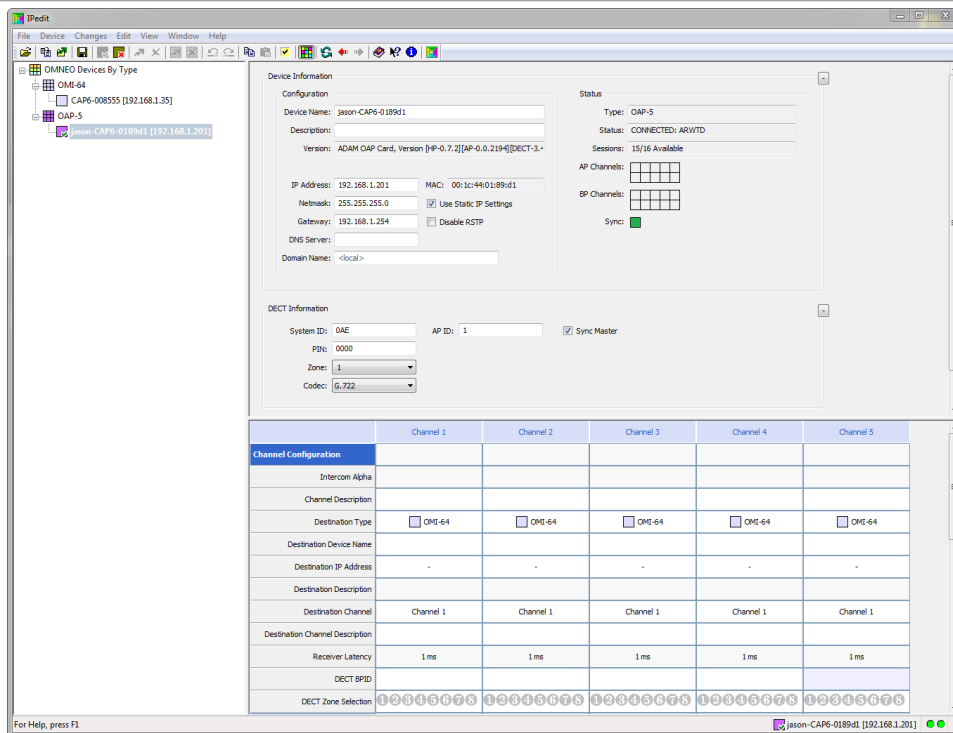
Figure 1: Configured AP

- Send all IPedit changes to the devices.
Wait until the “Sync” Status box is green (indicating the AP is synchronized and active).

System ID:	0AE	AP ID:	1	<input checked="" type="checkbox"/> Sync Master
PIN:	0000			
Zone:	1			
Codec:	G.722

- Add OMNEO Access Point (OAP) device and login as “admin” to make DECT changes.
Device→Change User, username: **admin**, password: **password**.
- Enter a valid “System ID” for the AP.
The “System ID” is a 3-hex digit entry (e.g., “0AE”).
NOTE: All APs within a *roaming system* must have the same “System ID”.

- Enter a valid “AP ID” for the AP.
The “AP ID” is a decimal entry (1-255).
NOTE: Each AP within a *roaming system* must have a unique “AP ID”.
- Setup the “Sync Master”
Check the “Sync Master” box for only one AP within the system.
NOTE: Only one AP within a *roaming system* must be selected as the “Sync Master”.

- Enter a “PIN” code.
Default “PIN” code is 0000.
- Select the desired “Zone”.
Default “Zone” is 1.
- Select the desired “Codec”.
Default “Codec” is G.722.
- Set “DECT Zone Selection” for each beltpack.
Default Zone Selection is blank (all zones).

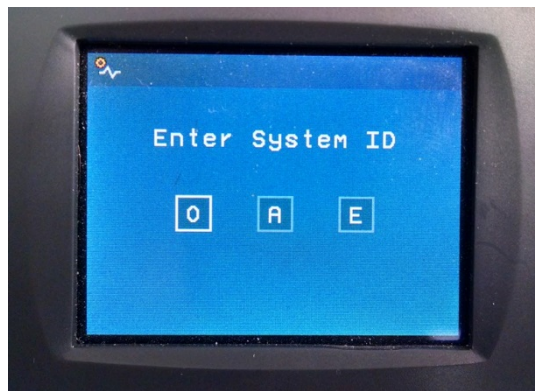
For example, if the “System ID” (as entered in IPedit) is “0AE”, the “System ID” should also be entered on the BP as “0AE” on the beltpack:
