# Technical Memo

**Subject:** Software Release [V3.20]

HDCM23-042R

| Model Name / Model Family Name | Model Name / Model Family Name | Model Name / Model Family Name | Model Name / Model Family Name |
|---|---|---|---|
| HDCU3500 | HDCU5000 | HDCU5500 | |

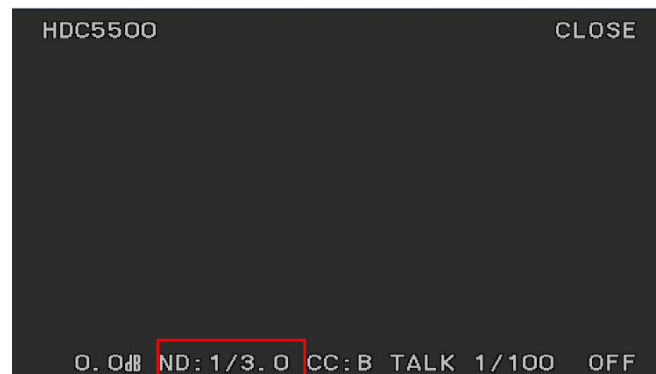
### 3. Supports a status display of Variable ND Filter Unit

When connected to a camera equipped with Variable ND Filter Unit, the transmittance of the variable filter will be displayed in the status menu.

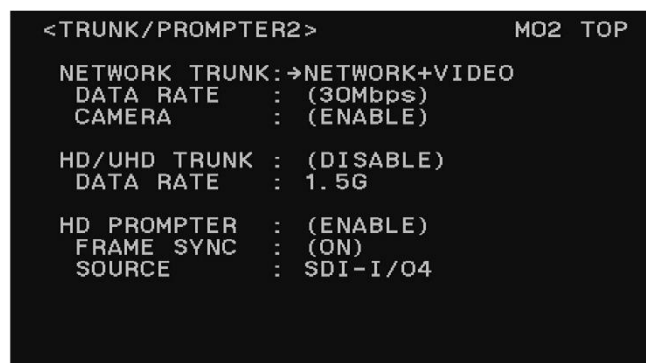
Select “Network + Video” from NETWORK TRUNK section in the page of M02<TRUNK/PROMPTER2>.

NETWORK TRUNK transmission line of approximately 30Mbps is added between Camera and CCU in the above Camera Format.

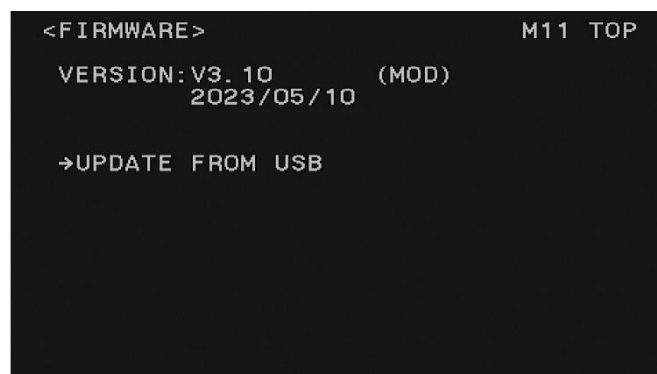
Execute “UPDATE FROM USB” on <FIRMWARE> page of the MAINTENACE MENU and will start update all software and PLD.
