Technical Memo

Subject: Software Upgrade(V6.12 -> V7.00)

Issue No.PMWM20-033

Model Name	Dest	Model Name	Dest	Model Name	Dest	Model Name	Dest
PXW-X500	CN	PXW-X500	SYM

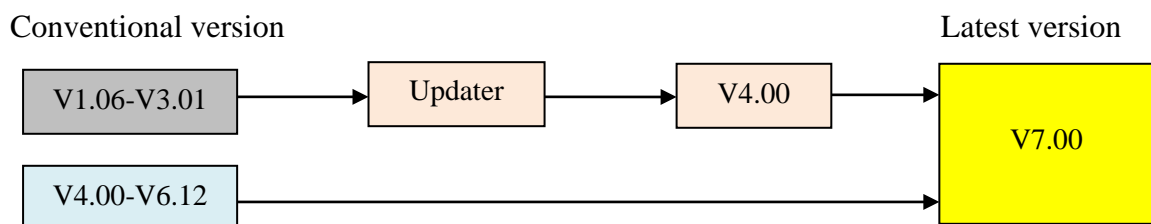
Combination of the software for the camcorder and the software for the network function

The combination of the software for the camcorder and the software for the network function must be either one in the table below.
