### Take Apart

## Bottom Cover & Interface Cable

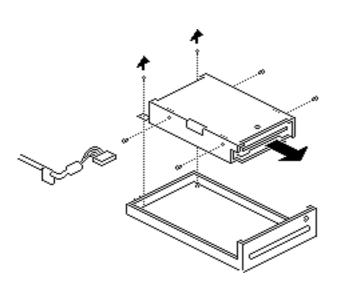
- Remove the four screws from the bottom cover.
  Lift off the bottom cover.
- 2 Remove the screw from the clamp that holds the interface cable and disconnect the interface cable.
