Service Issue Alert

Equipment: LDK6000 7" viewfinder

Problem : Picture is stretched vertically.

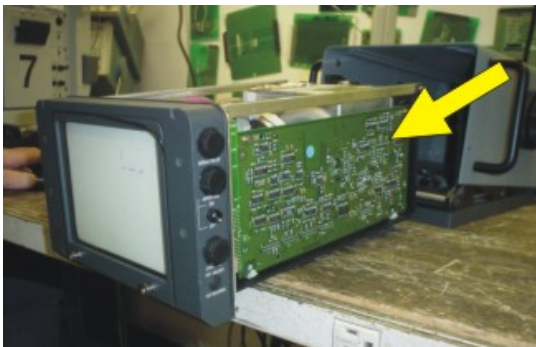
Area of modification

Remedy: Remove cover to gain access to circuit board or right side of viewfinder. As shown below

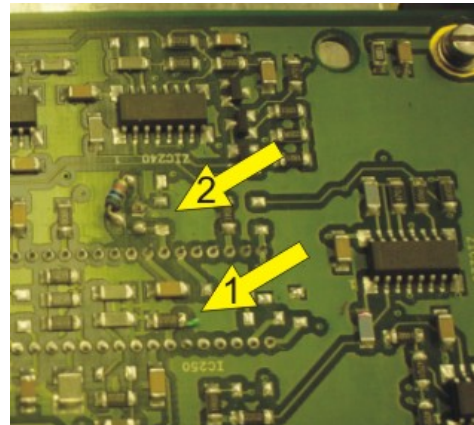
Remove green kynar wire at location 1
Remove transistor at location 2
Picture shows modification removed

*If the transistor or jumper is already removed and the problem persists, the problem is caused by another fault
